Treatment Report

Artist: William Orpen 1878 - 1931
Title: Welsh Landscape
School/Period: British 1911 (est.)
Support/Medium: oil on wooden artist board
Dimensions: unframed
33.1 cm. W x 23 cm. H x 0.4 cm D
Owner: Old Westbury Gardens
Frame: Wooden frame
Date of Treatment: 1/23/2018

Conservator:
Kimberly Frost, Masters' Candidate,
Conservation Center, Institute of Fine Arts,
NYU

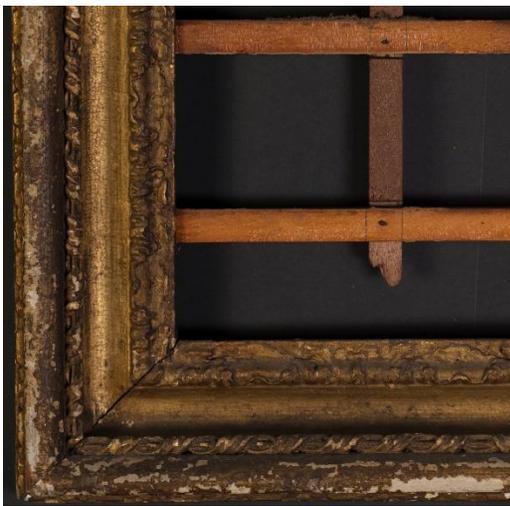
Detail of frame condition, before treatment.

The frame has collected a heavy layer of dirt and dust, especially along the top and side edges. The gesso ground exhibits active lifting throughout and losses revealing the bare wood below are visible, especially at the bottom right corner. The corner joins have a slight gap, but the frame is stable with no torsion.

Flaking paint and lifting gesso on the frame was consolidated with a dilute solution of PVA Jade emulsion adhesive. After being secured, the frame's surface was cleaned with an aqueous solution of 1% Ecosurf surfactant and 1% tri-ammonium citrate in water. Areas of missing material were filled with a stable acrylic putty, Flugger, to create level surfaces along the moldings of the frame. Fills and other small areas of loss were inpainted using Kremer metallic watercolors.

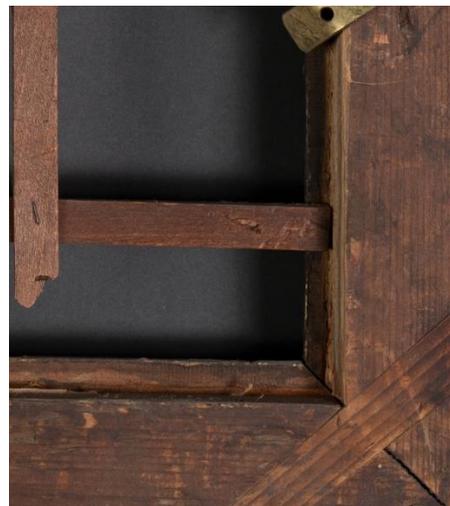
Along the sides two eye-screws and a wire are attached for hanging the painting. On the reverse, four brass mending plates in the center of each edge secure the panel in place. The rabbet of the frame indicates that it may have been increased on the bottom and right sides using a plane or carving tool to widen the rabbet. This suggests the frame might have been modified to fit the painting, and may not be original to the painting.

Detail on reverse of frame showing reworking along the right edge.

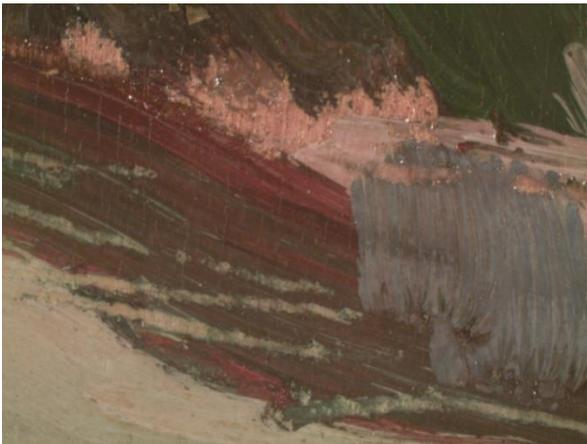
Detail image of scratching into wet paint.

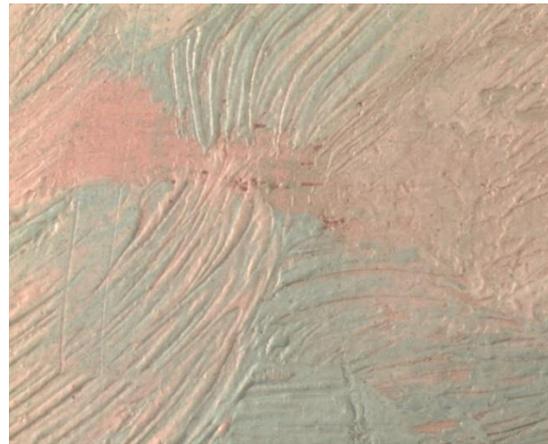
Detail of exposed preliminary layer in sky.

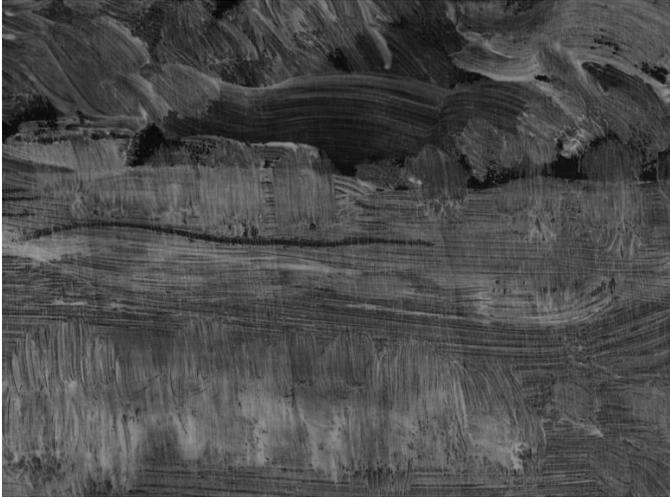
The paint layer is in good condition with small areas of loss along the top edge. Patchy areas of bare wood are seen along the vertical edges of the board, particularly at the top right. A fine craquelure has developed vertically across the surface in response to the grain of the wood layer below. This cross-grain craquelure is visible in X-ray images.

Detail of X-radiograph at right horizon line showing woodgrain and craquelure.

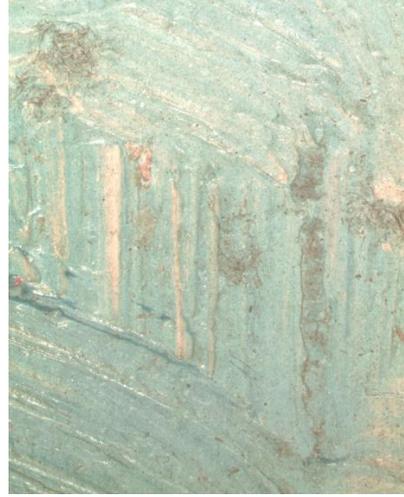
Small dents in the paint layer are observed around the perimeter of the painting, which could relate to damage from previous framing methods. Small accretions and damage on some areas of high impasto are visible during examination under the microscope.

Detail at 12.5 X magnification showing deposits on raised impasto in sky.

An isolating varnish of mastic resin at 8% dilution in triple distilled turpentine was applied by brush. Small holes were observed around the perimeter of the top edge. These damages appear to have been caused by nails used to secure the painting in its frame. The small holes were filled with a reversible acrylic putty, Flugger, and textured as necessary to match the surrounding surface. The small and isolated patches of accretions were reduced mechanically with a scalpel under microscope.

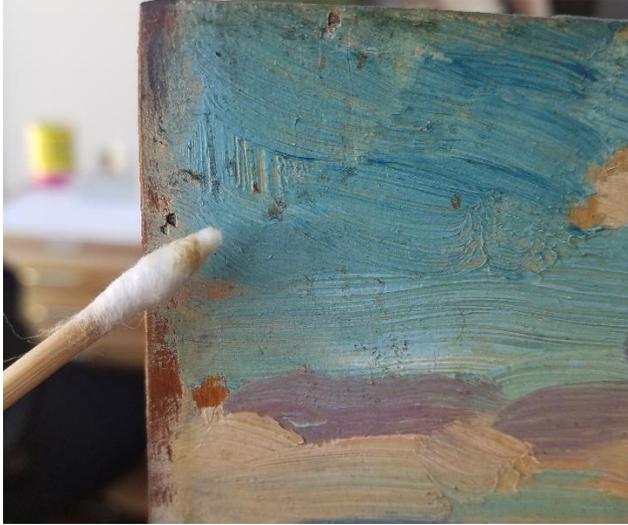
Swab cleaning test before varnish removal.

The reverse of the panel was gently dry cleaned with sponges and the front painted surface was cleaned with moistened cotton to remove loose dirt and dust. The discolored varnish was then removed with a solvent mixture of 1:1 Mineral Spirits and Acetone. No pigments were observed to be sensitive to the solvent mixture.

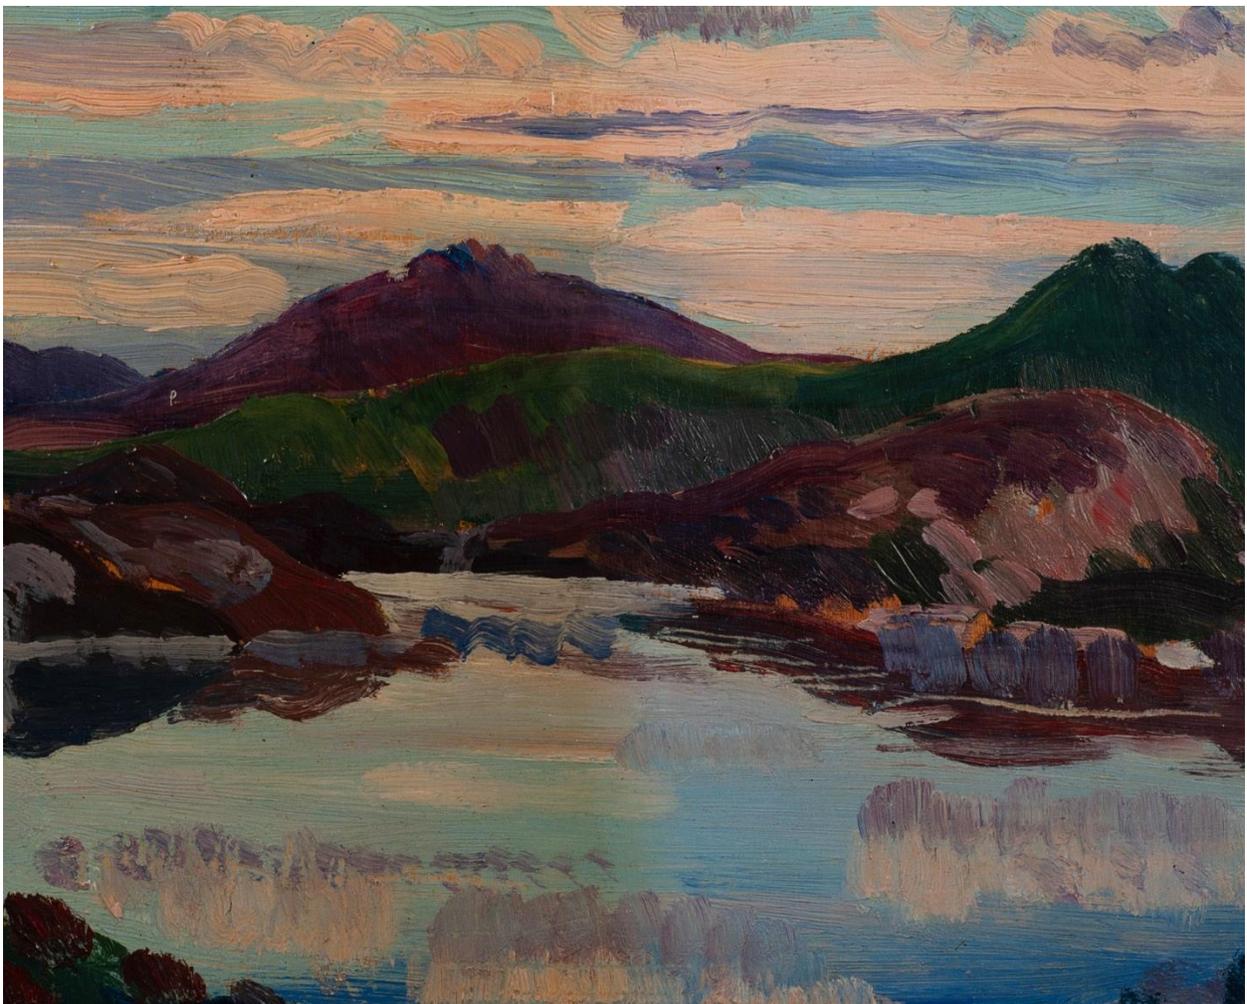
The varnish is covered by a significant layer of dirt and grime accumulation. The resin has darkened and yellowed over time, altering the bright palette of the painting.

Detail during removal of discolored varnish layer.

The removal of the varnish revealed greater textures of the impasto and the contrasting warm and cool tones of the artist palette. The varnish was mostly removed in the first pass, and a second pass was performed to clear the remaining residues from the painting's surface.

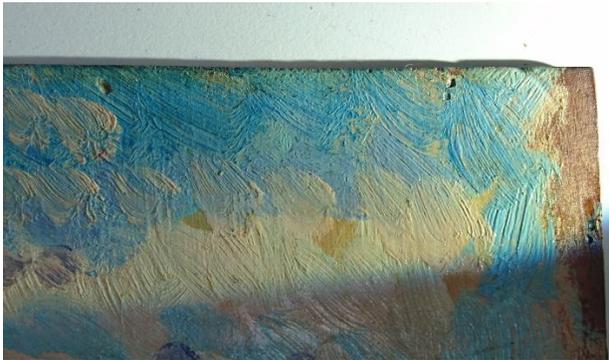
Detail in raking light before treatment.

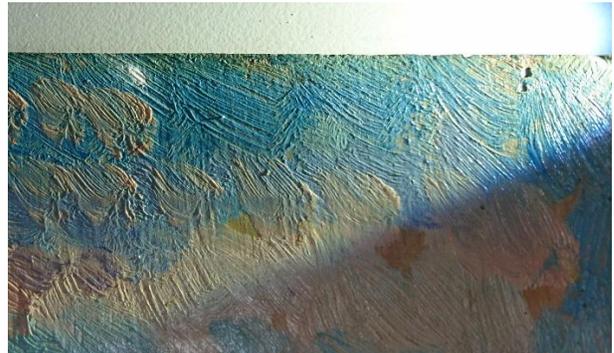
Detail in raking light while completing fills.

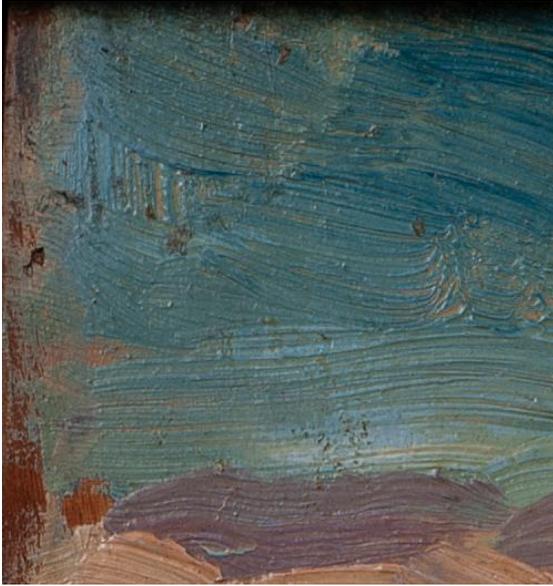
Top left corner before cleaning and inpainting

Filled damages were inpainted to match adjacent areas. Other small areas of damaged impasto were also inpainted to complete the surface brushstrokes. Inpainting was completed using water-reversible and stable QoR watercolors bound in QoR watercolor medium (Aquazol).

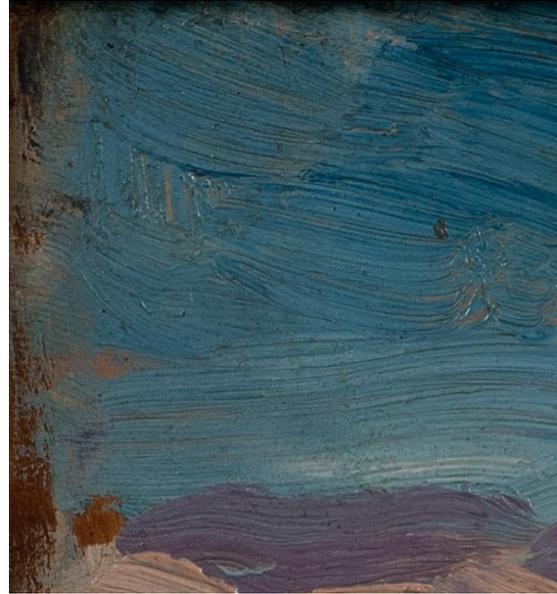
Top left corner after removing varnish and final inpainting

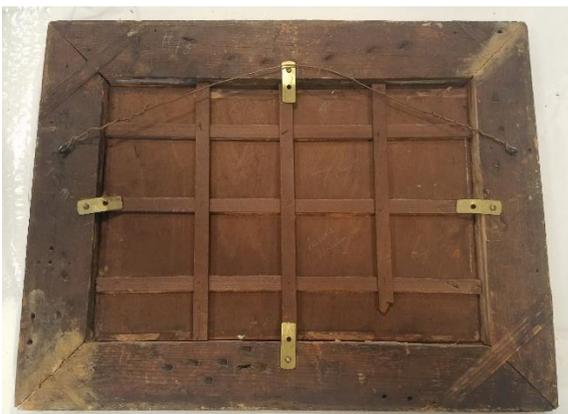
Reverse of frame, before treatment

After stabilization and treatment, the painting was returned to its frame. A thin strip of felt tape was added inside the rabbet to protect the painting's surface. A strip of balsa wood was added to fill at gap in the top of the frame and hold the painting securely in place. The thin cradle remains detached and was placed loosely back in the frame without any adhesive. Six brass mending plates were secured with brass screws along the edges to hold the cradle and painting in the frame.

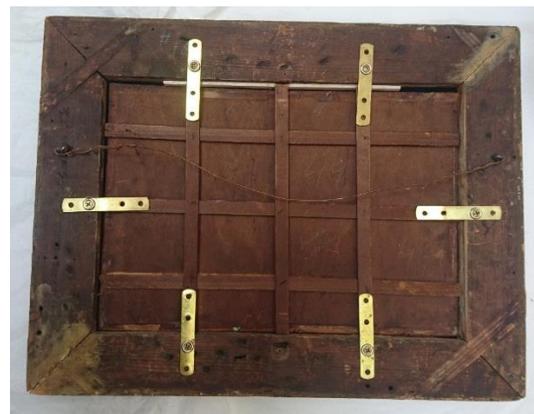
Reverse of frame, after treatment
