**Foundation Number:** HSF0172

**Artist:** Hedda Sterne

**Title:** Airport

**Date of Treatment:** 09/01/2017

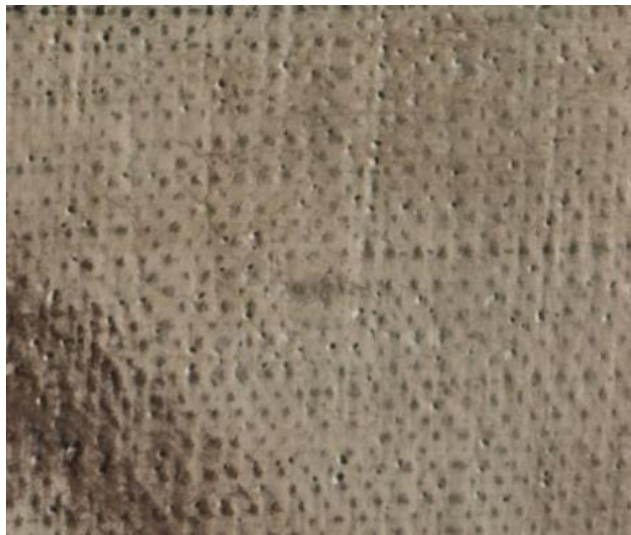
A ground of cream-colored primer is thinly and evenly applied across the canvas extending to the cut edges. Based on the appearance of pinhole bubbles in areas of exposed ground it appears to be a commercially applied priming layer. Areas of ground remain purposefully exposed within the composition. Two types of drawing media are evident: lines that appear dry and thin are estimated to be a graphite pencil; a second drawing material creates thick, soft lines in deeper black, and is estimated to be of an oil stick or crayon bound pigment. Drawing media is both painted over and left exposed at the uppermost layer throughout the image.

Image 1: Detail image in raking light showing pitted bubbles found across visible areas of the ground layer.

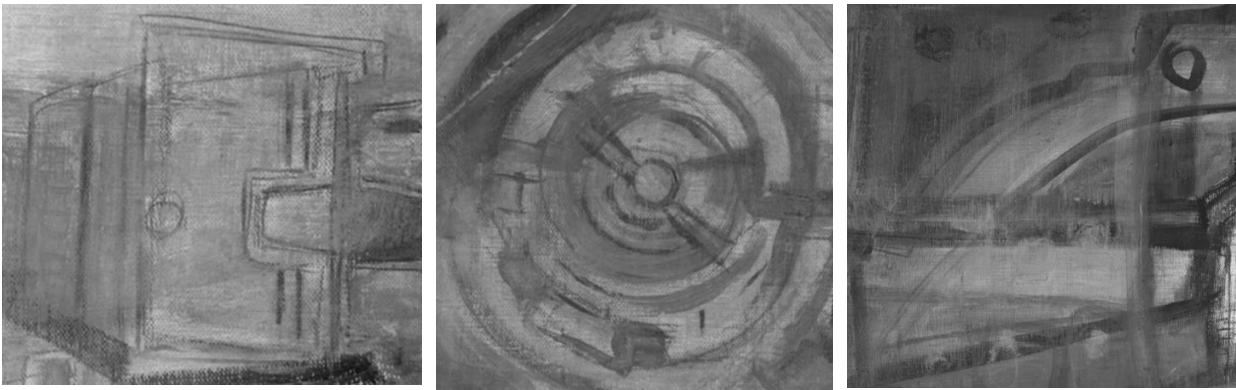
Image capture with infra-red reflectography shows that multiple changes were made in the drawing and paint layers underneath the present surface of the painting, both during its first iteration and Sterne's later interventions. Thin lines of a dry, carbon-rich medium are seen in the detailed drawing of the horizontal

abstracted rectangle in the upper right quadrant, which is visible in the archival images of 1950. This same medium is used to outline a circular design at the center of the lower edge. This element appears to have been partially painted out by Sterne before 1950. In the archival images dated to 1950 and 1951, the circle's exterior shape is visible while its interior angular lines are not visible.<sup>4</sup> In the current state, this design is barely visible when viewing the painting in normal light. Finally, a bold and thick line of a carbon-rich material, possibly a softer drawing medium or liquid medium is seen in the top left quadrant. This distinct medium fills the quadrant with triangles, small circles and a jagged curved line, none of which are visible in the 1950 archival images and must have been painted over by Sterne before this date.

Image 2: Detail images from infrared reflectography of Hedda Sterne's *Airport*, 1949.

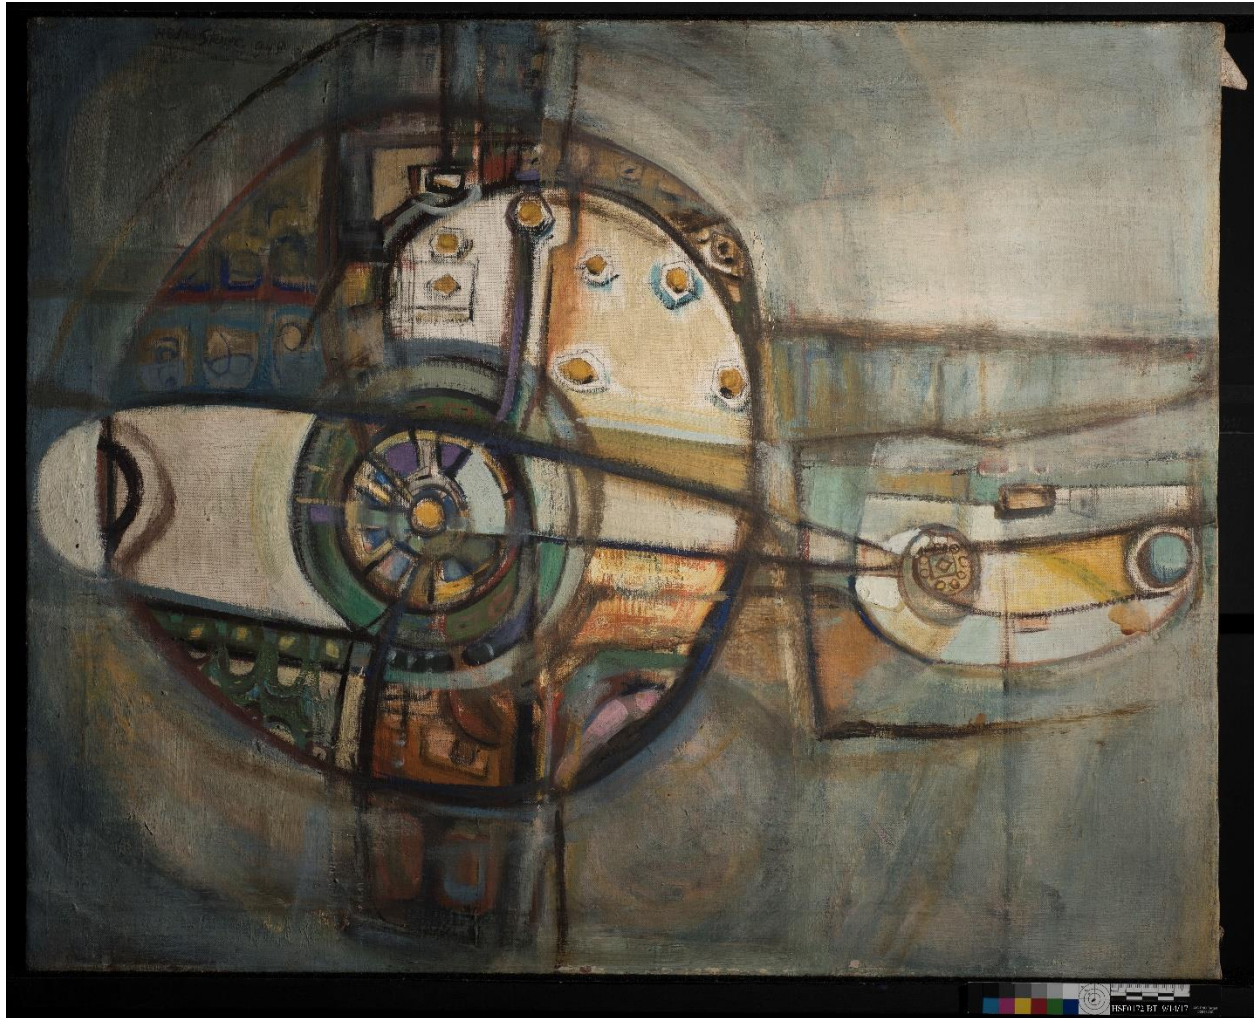
The canvas retains good flexibility and strength, and is slightly darkened to a light brown color. The canvas is slack with pronounced undulations across the total surface area. Overtime, movement of the loose canvas has caused repeated contact with the inner edge of the stretcher bars, resulting in raised stretcher bar marks and associated mechanical cracking in the paint layers. This is most notable when viewing the canvas in raking light.

Image 2: Before Treatment, Front in raking light

11. In the future, humidification treatments to reduce canvas undulations; and adding auxiliary supports or keying the stretcher to mitigate the impact of stretcher bars should be considered.

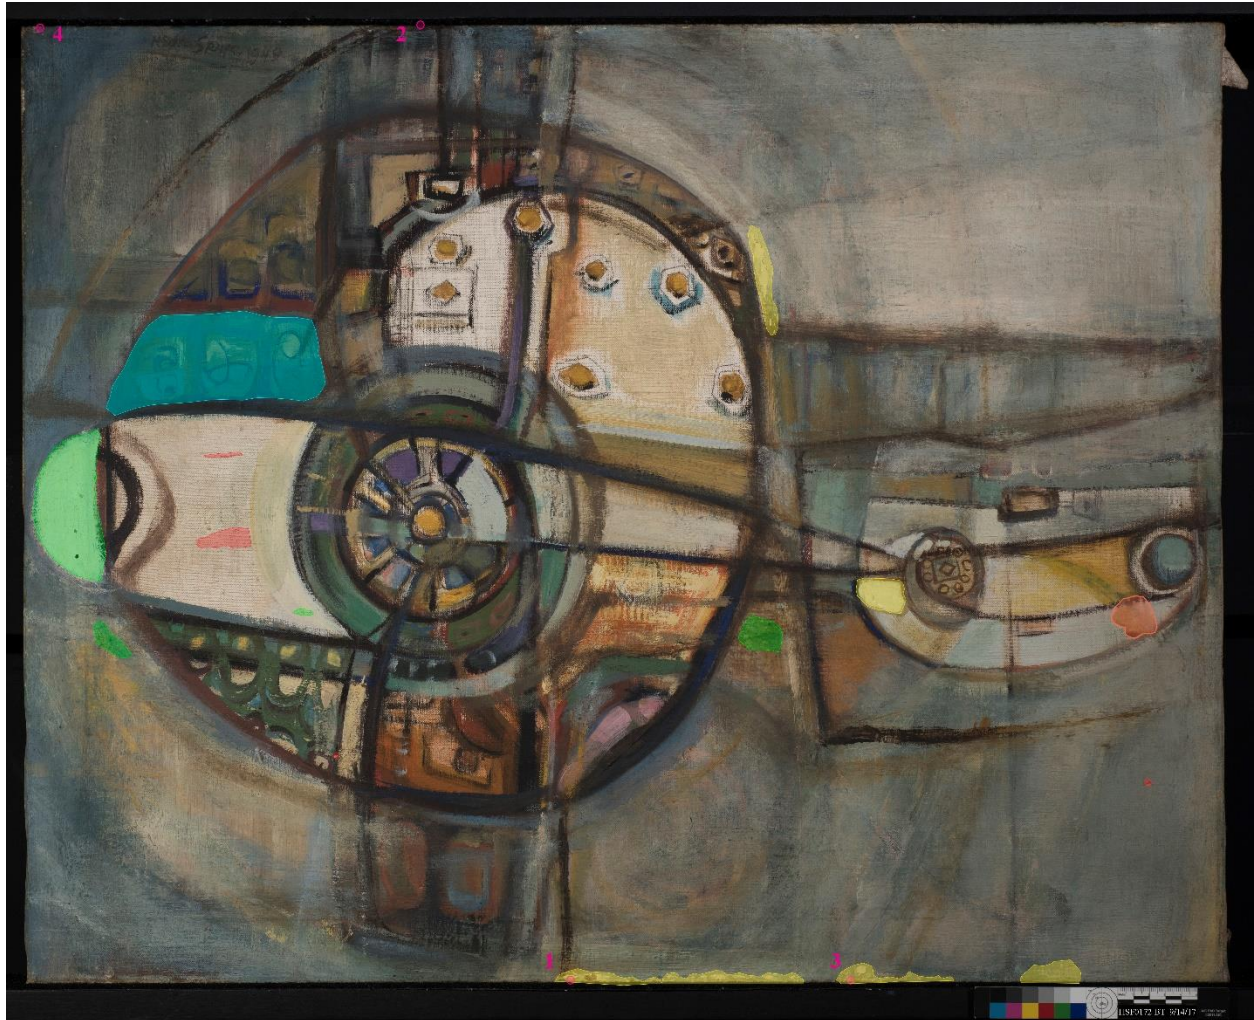
- |   |  |

| cross section sample locations | lifting and active flaking |
| staining | drying cracks |
| losses in ground / canvas visible | raised cracks |

Image 7: Before Treatment Annotated image showing surface conditions.

2. Lifting paint, raised cracks were consolidated by applying sturgeon glue diluted at 5% in water, and locally applying gentle heat and pressure until no lifting motion was observed in the paint layer. Consolidant was also applied to the edges of existing losses to prevent future damage, especially in losses of the ground layer throughout the entire turning edge.

9. Losses in the paint layers were filled with a gesso made from 7% rabbit skin glue with calcium carbonate and white kaolin clay. After dry, fills were shaped to an appropriate texture using a scalpel and fine metal or wooden tips.

10. Lost areas were then compensated with reversible water-soluble inpainting materials. A mixture of gouache and watercolor was suitable for areas with opaque colors and a delicate eggshell shine. Further gum arabic binder was added, as necessary, to increase gloss and match surrounding paints with more shine. In matte areas, Rembrandt artist pastels were used for inpainting. Pastels were applied both as a dry powder using by a small, cut sponge, and as a paint using a wet brush, depending on the desired concentration and coverage.

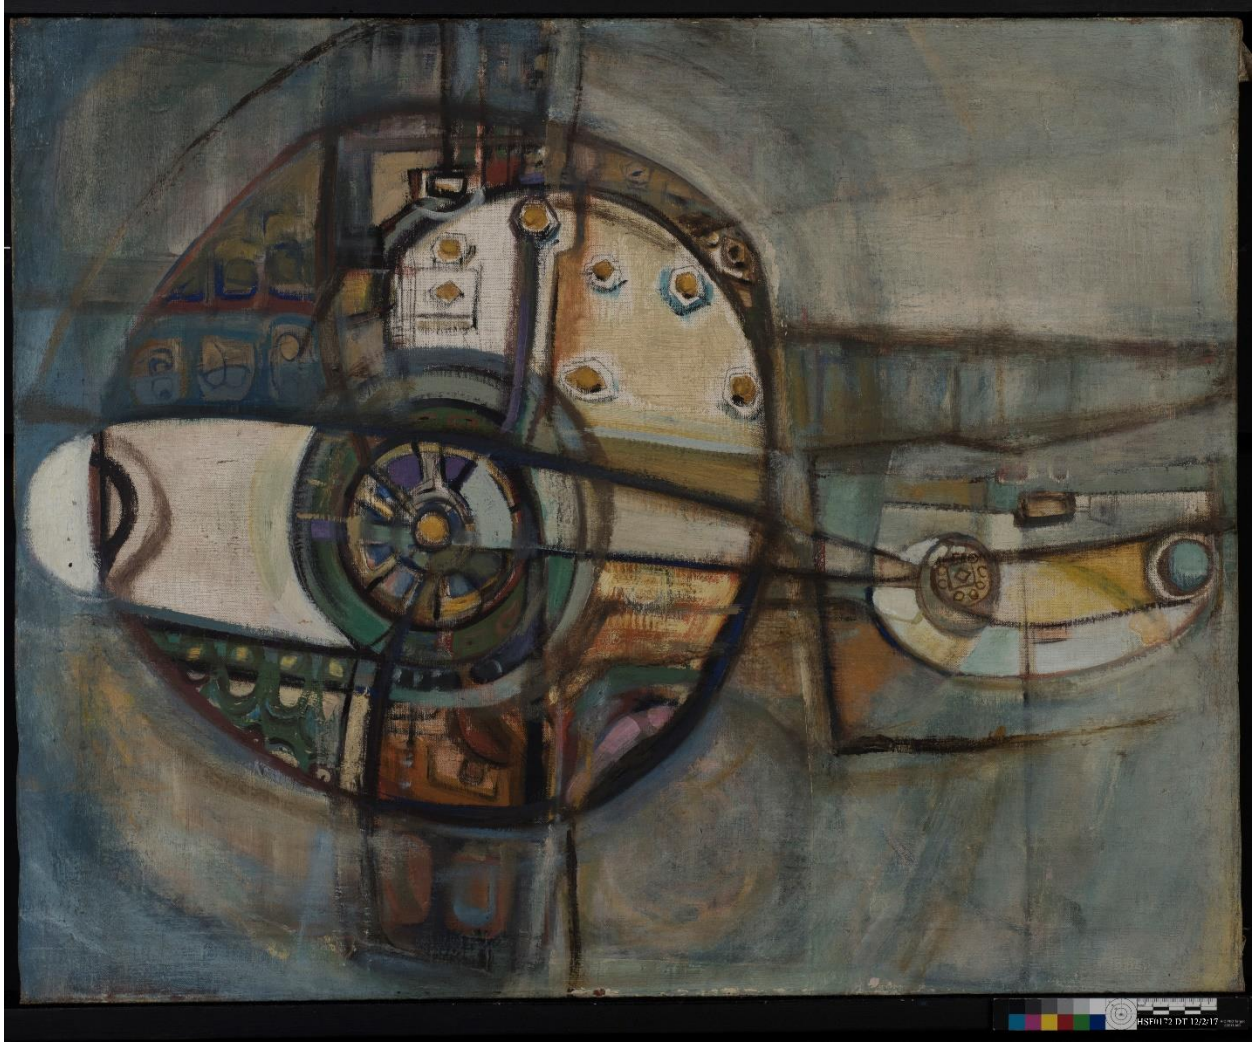
Image 8: During Treatment, Front, photograph in normal light. Lower half of the painting has been cleaned with aqueous solution.

5. Cleaning tests were performed with solutions of: water, 1% ecosurf EH9 from Dow Chemical (surfactant) in water, 1% Tri-ammonium citrate (chelator) in water, and 1% ecosurf and 1% Ammonium citrate in water. The solution containing both ecosurf and ammonium citrate was chosen as the best cleaning solution since it removed the most surface soiling with the least amount of physical action on the delicate paint surface, while acting at a controllable rate.

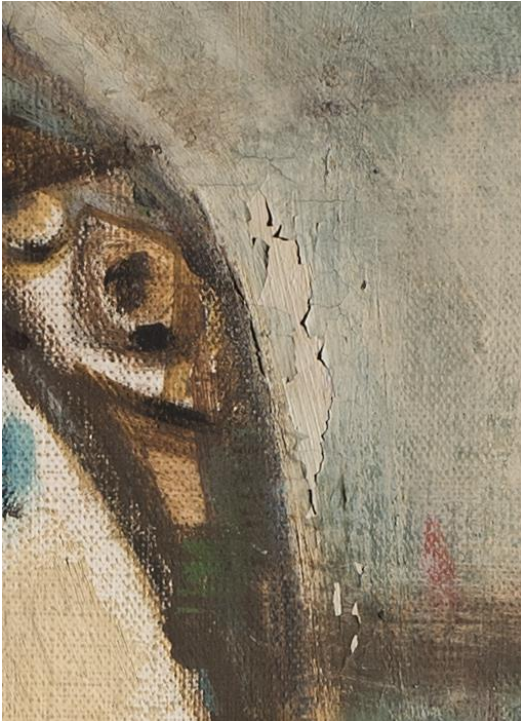
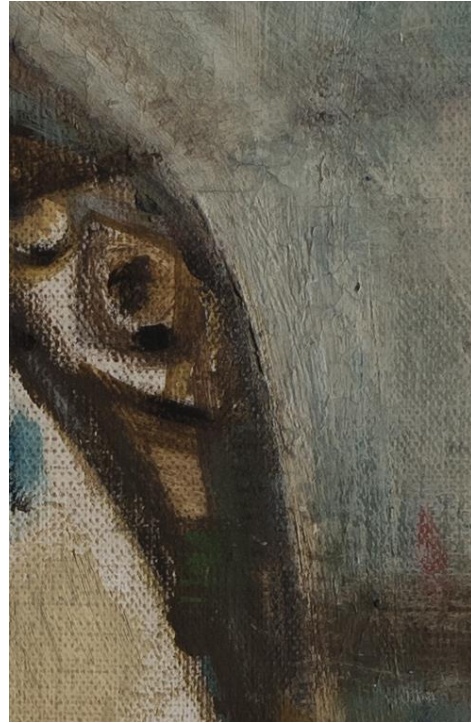
Image 9: Left, detail before treatment in raking light. Right detail after treatment in raking light.

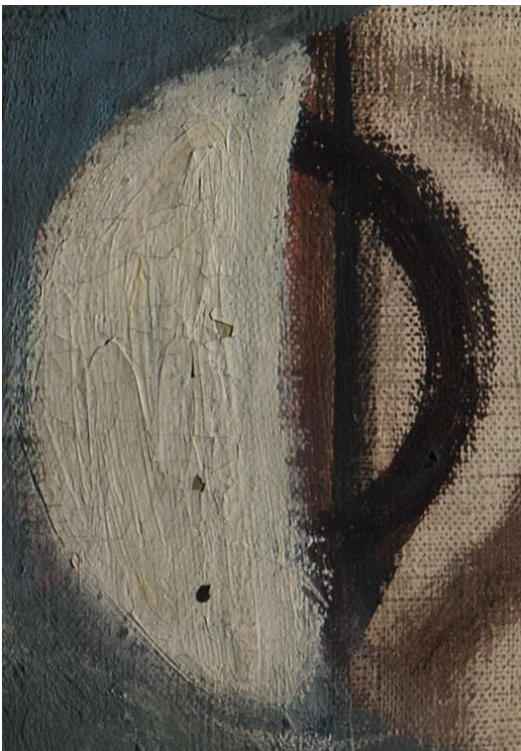
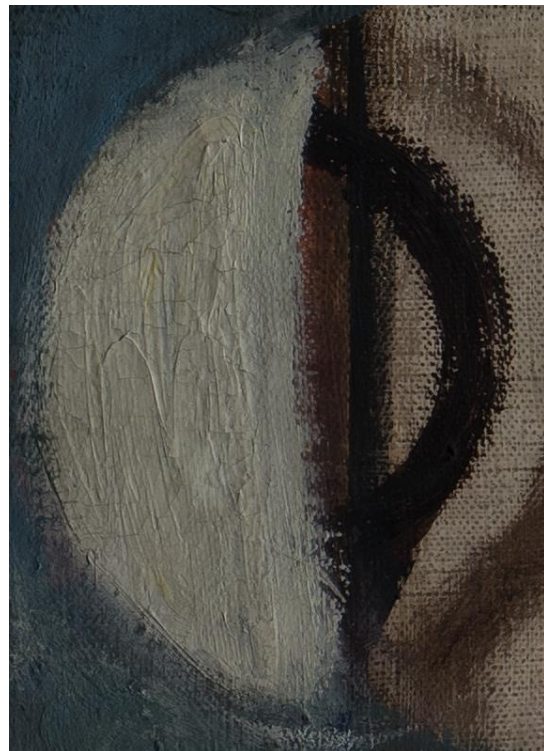
Image 10: Left, detail before treatment in raking light. Right detail after treatment in raking light.

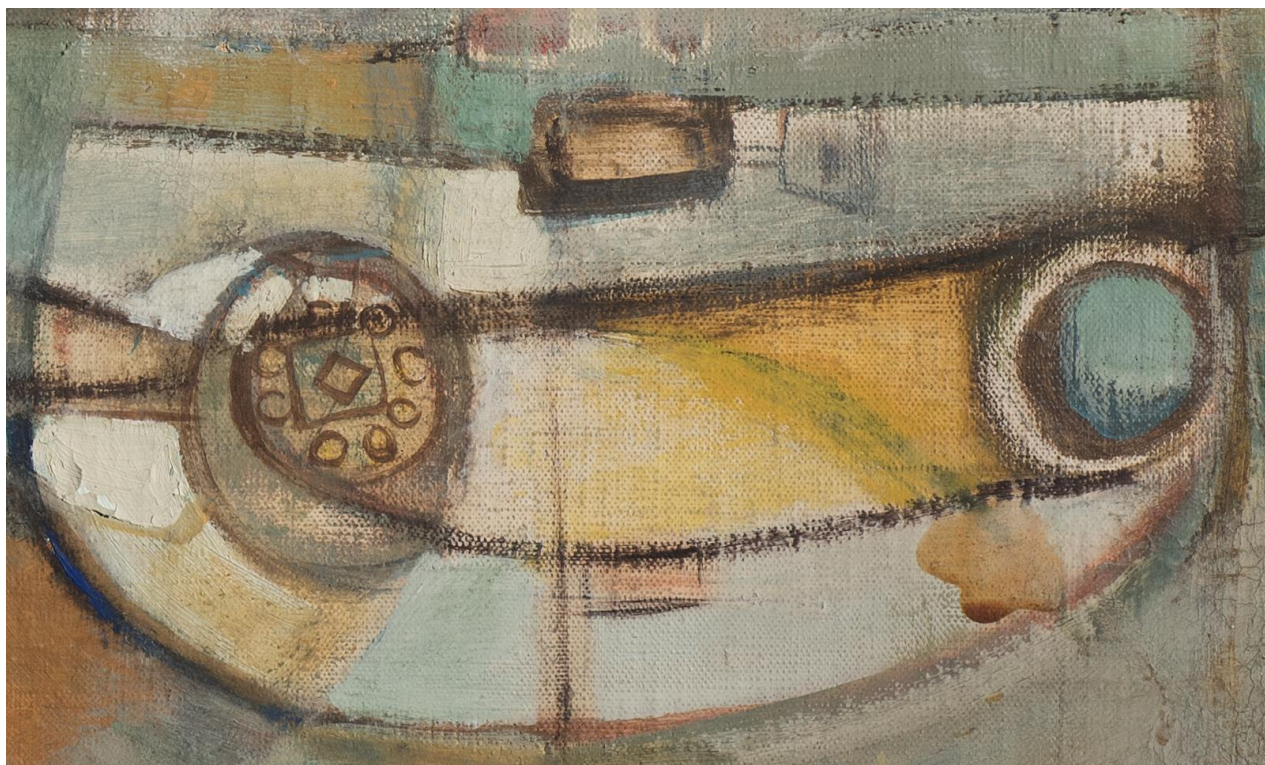
Image 11: Detail, Before treatment in raking light.

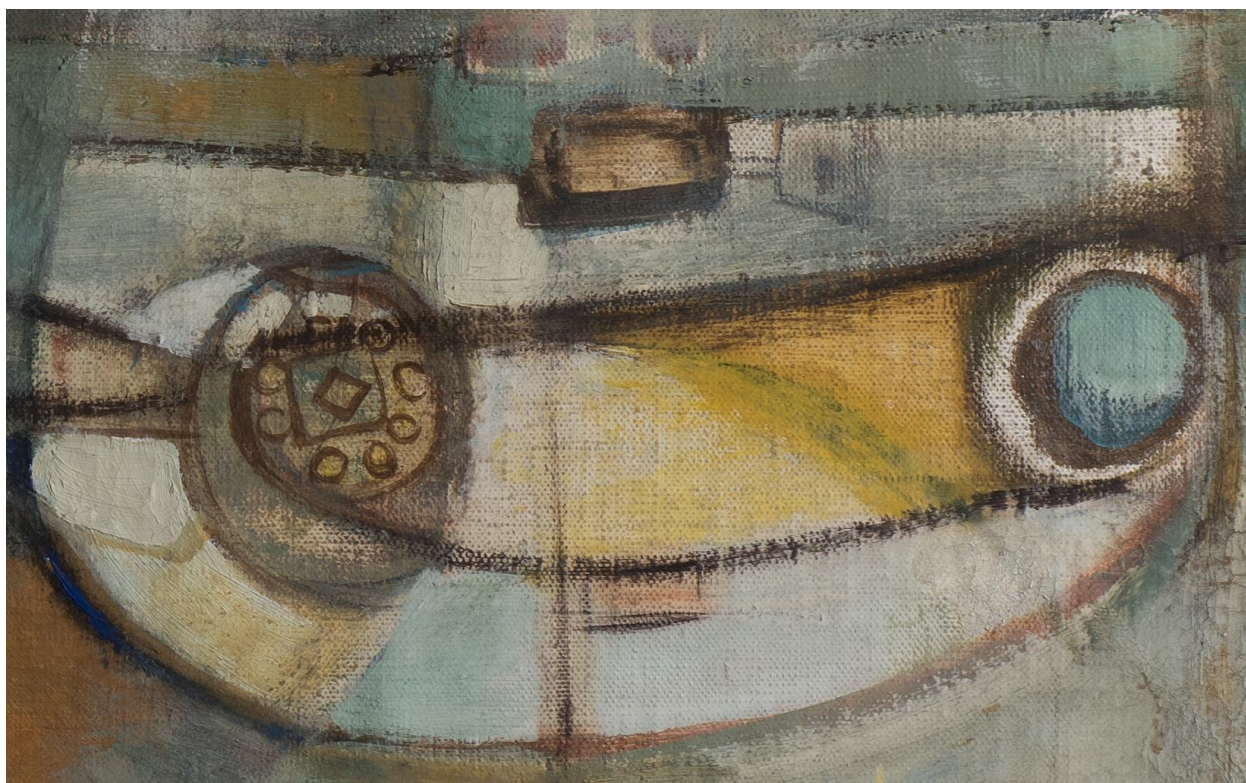
Image 12: Detail, After treatment in raking light.
