Morland – The Water Mill, 2018

## Treatment Report

**Artist:** George Morland  
**Title:** The Water Mill  
**School/Period:** British, c. 1780-1790.  
**Support/Medium:** oil on canvas  
**Dimensions:** 33.5cm. H x 44.7 cm. W x 1.5 cm D  
**Owner:** Old Westbury Gardens  
**Frame:** Gilded frame, original to painting  
**Date of Treatment:** 1/23/2018

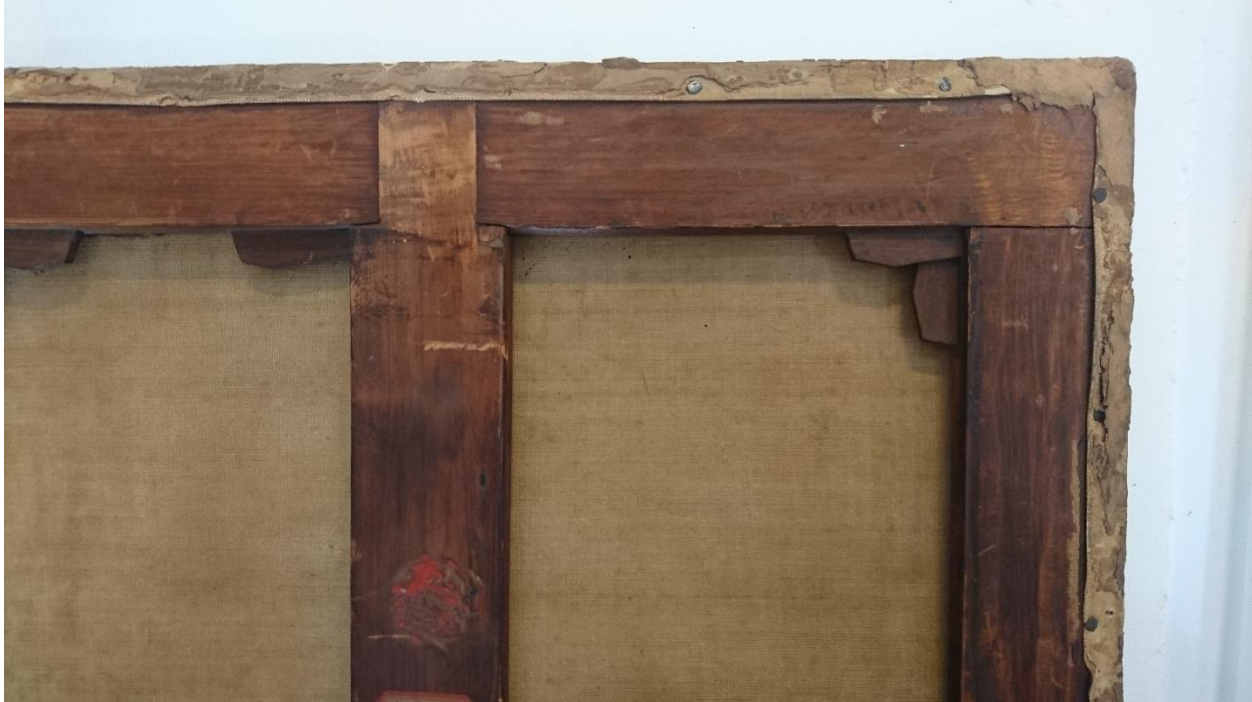
The stretcher is structurally sound and in good condition. There is a heavy layer of dirt and dust accumulation along the edges of the bottom keys and stretcher bar. The reverse of the lining also carries a layer of dust. The lining is fully adhered to the original canvas and the painting is held at appropriate tension with no undulations in the plane of the canvas. The tacking edges consisting of the lining fabric are in good condition with only two small holes at the center of top and bottom outer edges of the stretcher bar.

Detail of paper covering on the tacking edge before treatment.

The reverse of the canvas and stretcher were dusted to remove loose dust. Several pine needles were found between the bottom stretcher bar and the canvas, causing a slight protrusion. These were removed, and the protrusion relaxed by applying a gentle weight overnight. The canvas reverse and stretcher were then dry cleaned with Absorene rubber sponges to remove accumulated particulates. The brittle remains of the paper tape glued along the tacking edges was removed by scalpel.

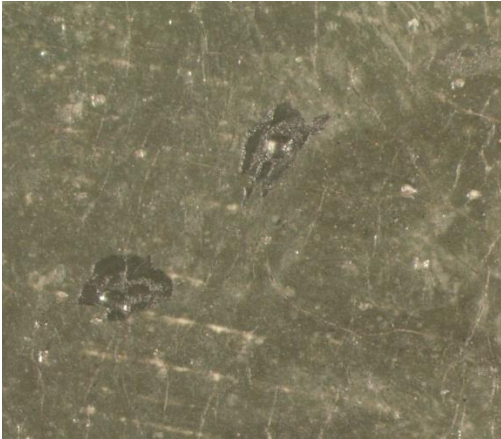
The ground layer is in good condition with no visible losses or damage. After cleaning, it became evident that the white ground was visible through small pinhole losses in the paint layer. During microscopic examination, these white spots protrude from the surface and often have a translucent quality characteristic of lead soap formation. Lead soaps are often formed from ground and paint-layer interactions and the effects of ageing binding mediums. The ground appears radio-opaque and thinly applied in the X-ray image. These observations indicate that the ground layer may contain lead white.

Detail of retouching over surface protrusions.

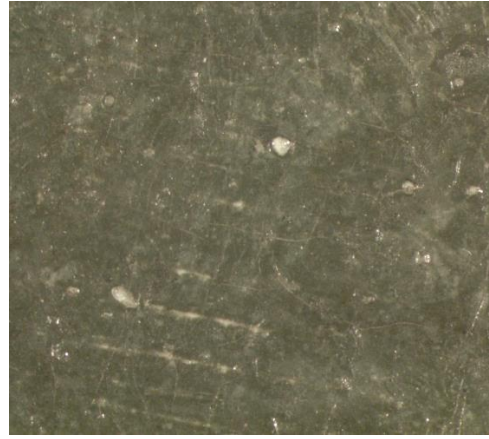
Detail of white protrusions after cleaning.

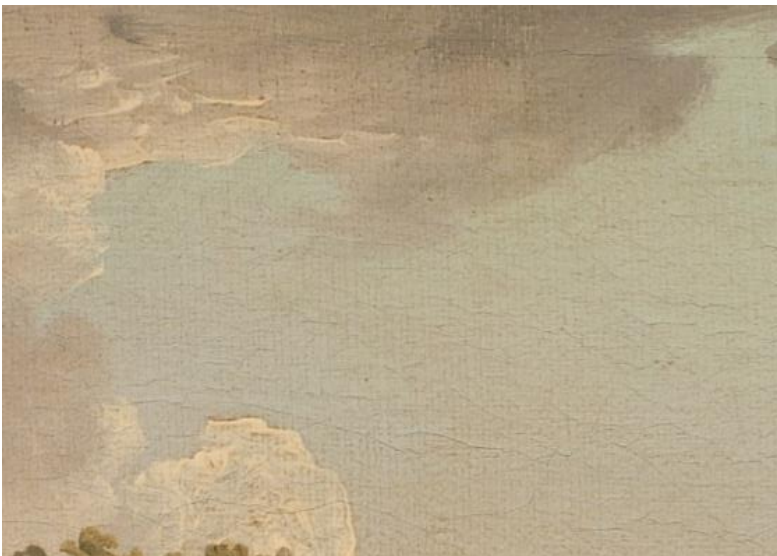
The paint layer has developed a fine craquelure network which is stable. No cupping or lifting of the edges is observed. The craquelure is most pronounced in the large portion of the exposed blue sky. Mechanical cracking caused by impacts can be seen along the inner edge of the stretcher bars and in a concentric pattern in the top right of the painting, in the sky.

Detail of crack pattern observed in the sky.

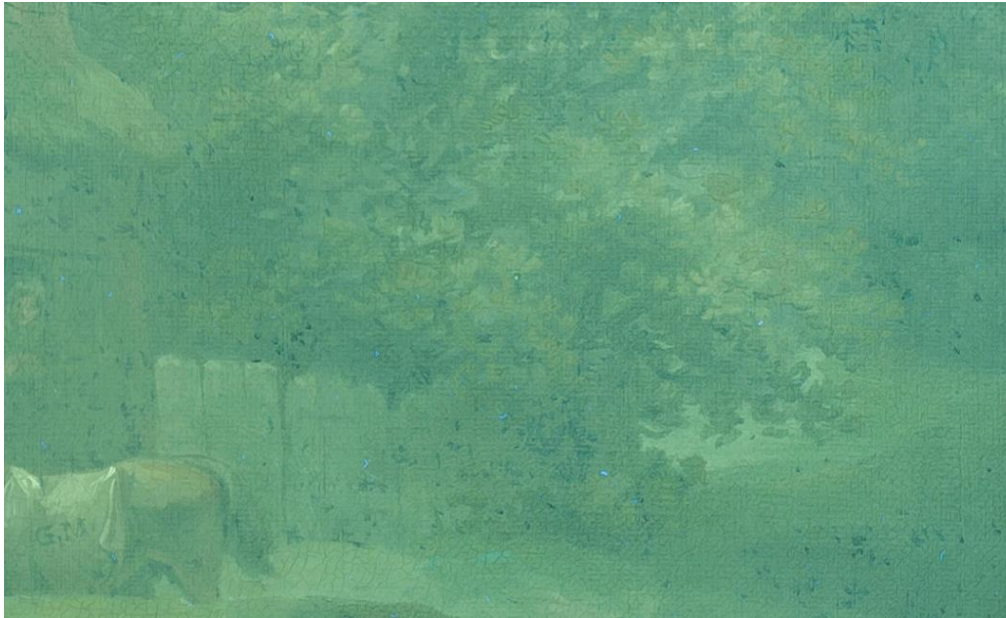
Some weave emphasis from the lining is evident, as for example, in the area of pooled water below the mill. The thinly applied paint layers are slightly abraded throughout, especially in the darks. Abrasion is also noticeable at the cut edges of the original canvas, which sit above the lining. During UV examination, small dark dots were visible throughout the landscape. This suggests that the surface has been retouched to eliminate the small white spots caused by the abrasion of protrusions in the paint layer.

Detail of dark spots seen under UV examination

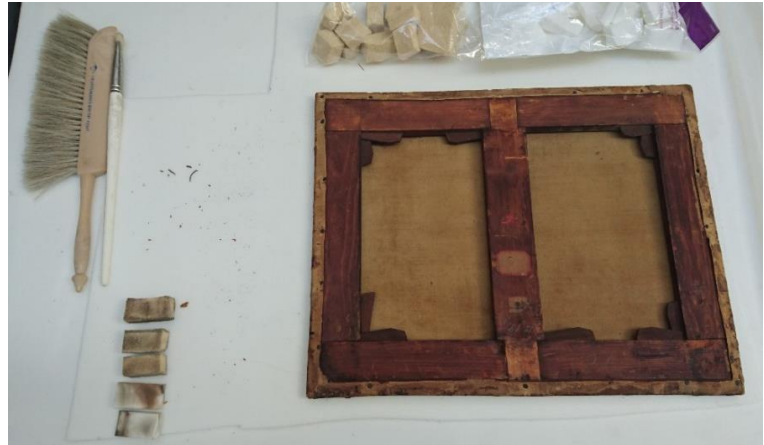
Left side of the canvas is significantly lighter after dry cleaning with sponges. Pine needles can be noted in the removed debris.

Removal of the brittle paper tape and glue adhesive with scalpel.

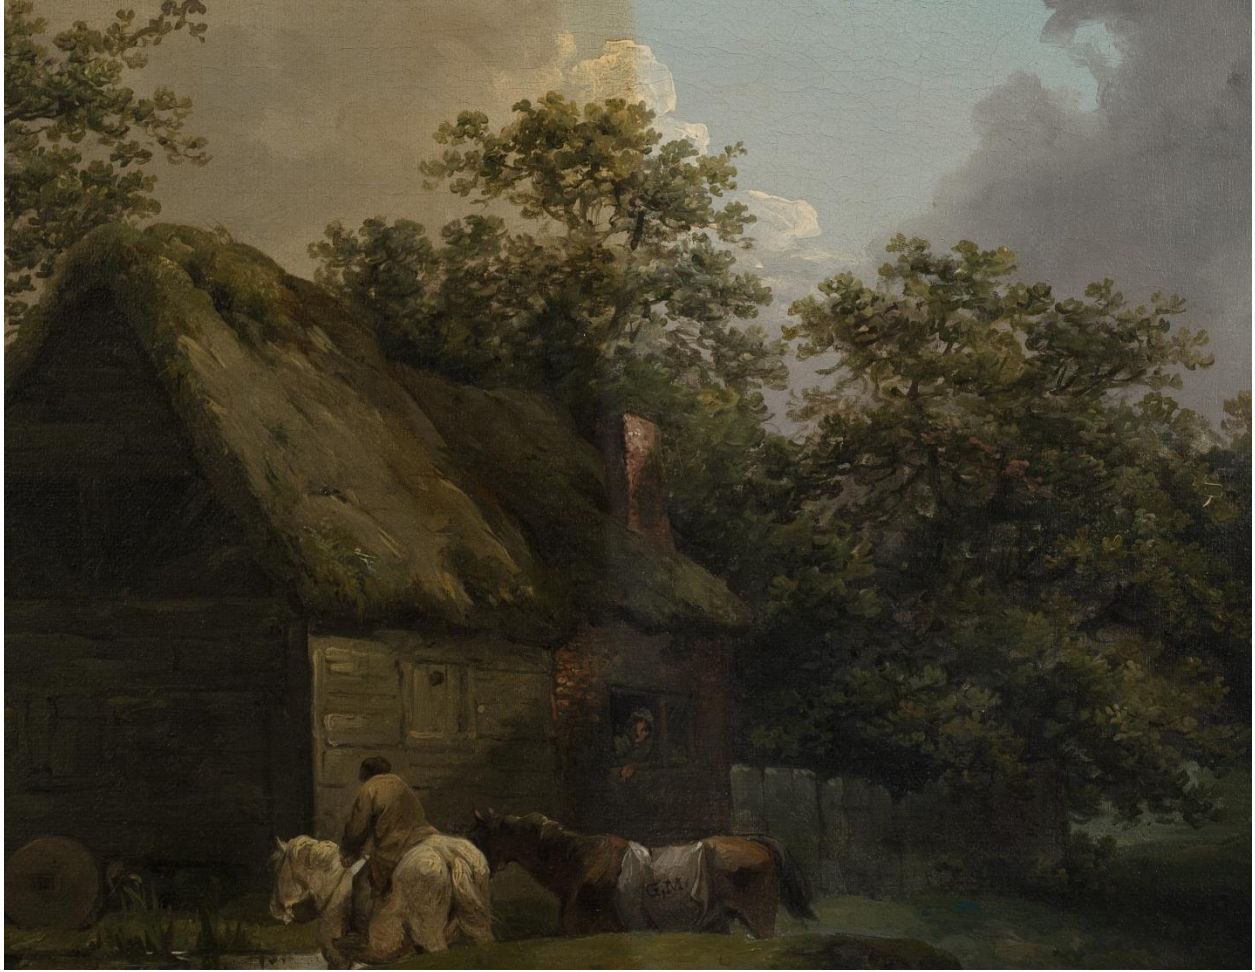
The natural resin has darkened and yellowed over time, obscuring the subtle details of the painting technique and original palette. The varnish is strongly discolored to a yellow-brown tone, as was revealed by a cleaning test from 3-5 cm below the upper right corner, showing the original. White spots of localized blanching are observed in the top and bottom edges of the painting covered by the rabbet of the wooden frame.

Detail during solvent cleaning of discolored varnish.

The discolored varnish was then removed with a solvent mixture of 1:1 Mineral Spirits and Acetone. No pigments were observed to be sensitive to the solvent mixture. The retouching spots from a previous treatment did not match the true colors of the original paint layer and necessitated removal. The previous retouching was not sensitive to solvent action. Instead these were mechanically removed from the surface using a scalpel under high magnification.

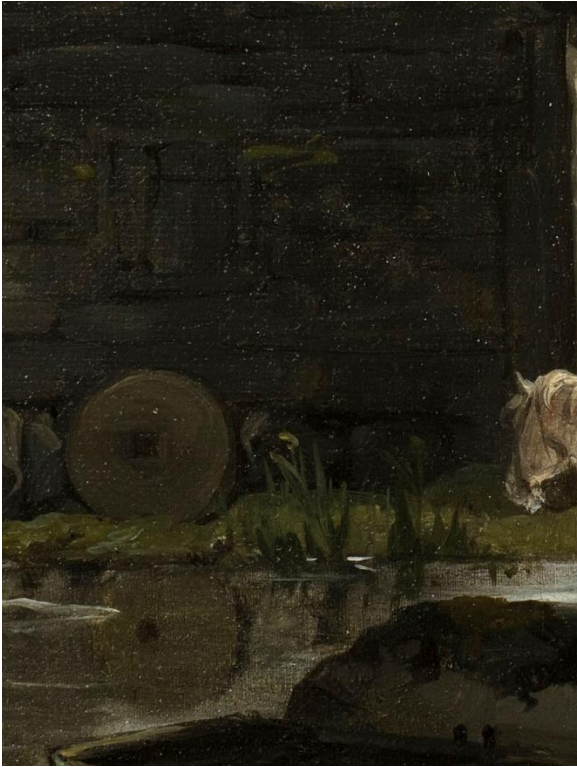
Detail of pinhole losses in cleaned state.

Inpainting aimed to reduce the visual disruption caused by the pinhole losses, especially in dark areas. Where discolored retouching could not be safely removed, especially in the sky, they were scumbled to visibly match the surroundings.

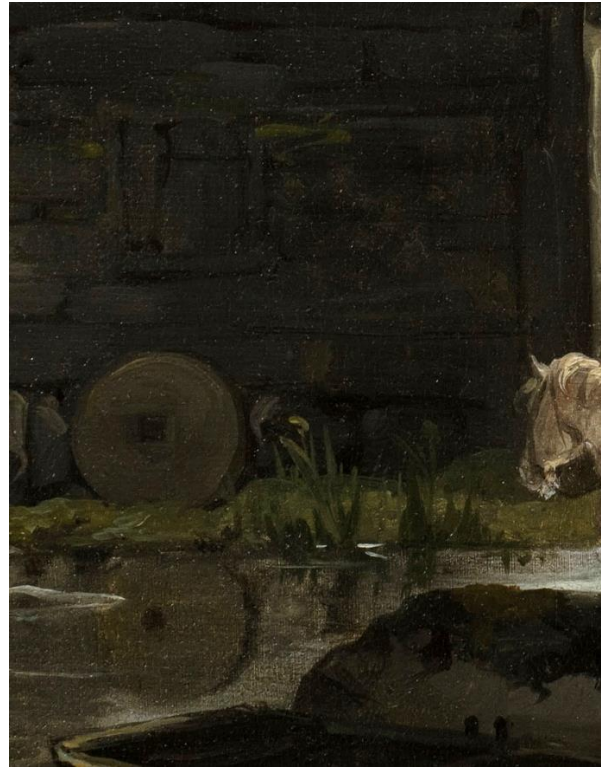
Detail after inpainting to cover pinholes and reduce abrasion in the water below.

Inpainting was completed with a precise brush using Qor watercolors in Aquazol medium.

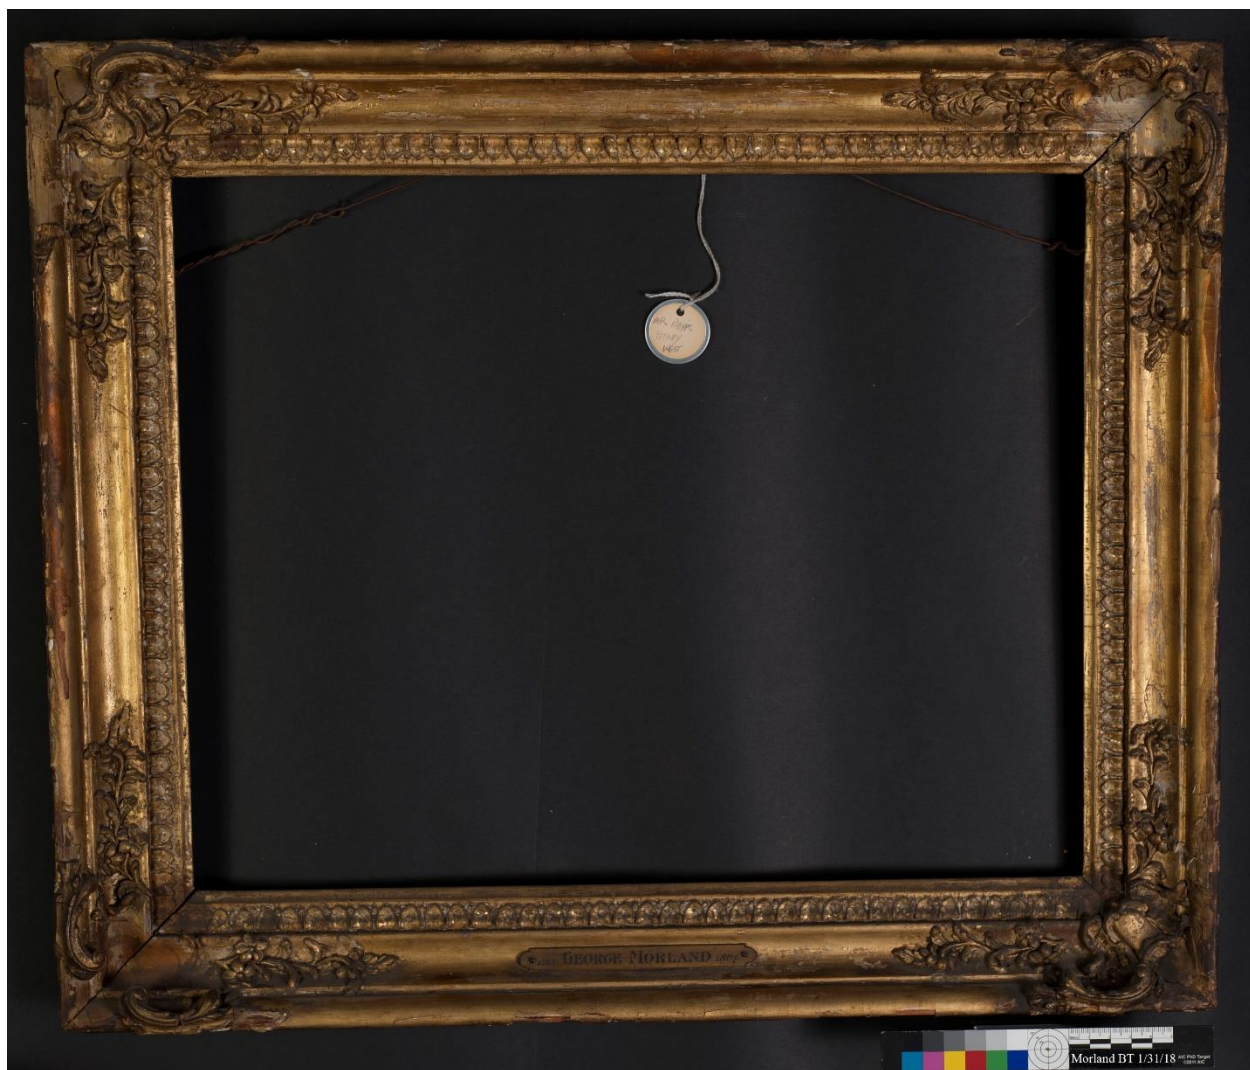
Frame, Front

The frame is in very poor condition with large losses and active flaking. Two of the attached leaf decorations are lost along the outer edge of the top left and bottom right corners. Two shield decorations on the interior face are also missing in the top right and lower left corners. Large losses of gesso along the outer edges have left bare wood visible. In some areas, this has been carelessly toned with overpaint, which occurred in several campaigns. Cracks, lifting ground, and loss are also scattered throughout the interior cove of the molding. A heavy layer of dirt, dust, and grime has accumulated over the surface. Due to the extensive damage of the frame it will not be conserved at this time. It is recommended that the frame be replaced by an appropriate reproduction or period frame to suit the painting.
