Treatment Report

Artist: William Orpen 1878 - 1931
Title: Welsh Landscape
School/Period: British 1911 (est.)
Support/Medium: oil on wooden artist board
Dimensions: unframed
33.1 cm. W x 23 cm. H x 0.4 cm D
Owner: Old Westbury Gardens
Frame: Wooden frame
Date of Treatment: 1/23/2018

Conservator:
Kimberly Frost, Masters' Candidate,
Conservation Center, Institute of Fine Arts,
NYU

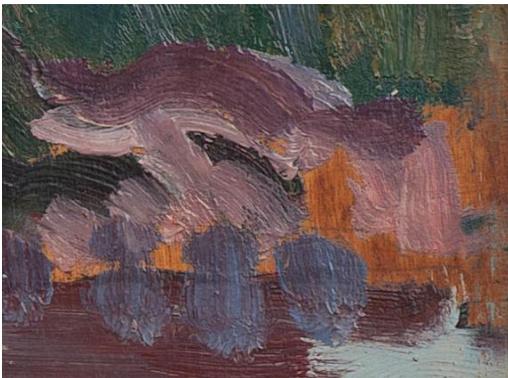
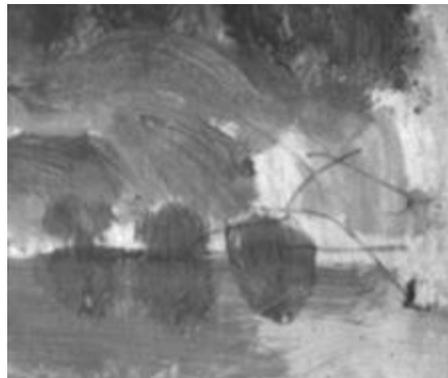
The painting does not appear to have an applied ground layer. Areas of the wooden support remain visible throughout the bottom half of the composition in the landscape of mountains. Near the right edge of the horizon some unpainted areas appear also have the remains of a light graphite drawing or sketch. This suggest the artist drew his composition directly on the wooden support. Examination with infrared reflectography showed that the lines made with carbon containing material also extend under other sections of the landscape.

Detail in normal light.

Detail in infrared reflectography.

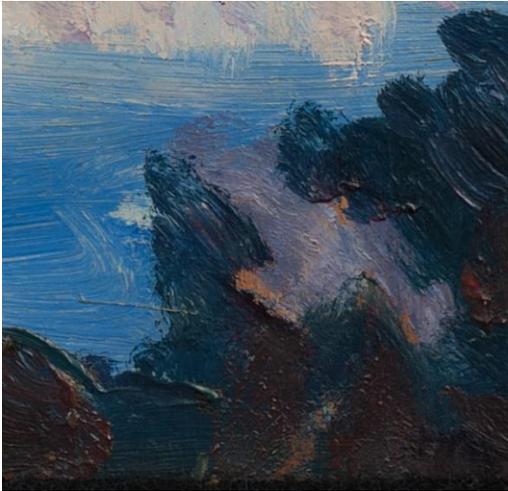
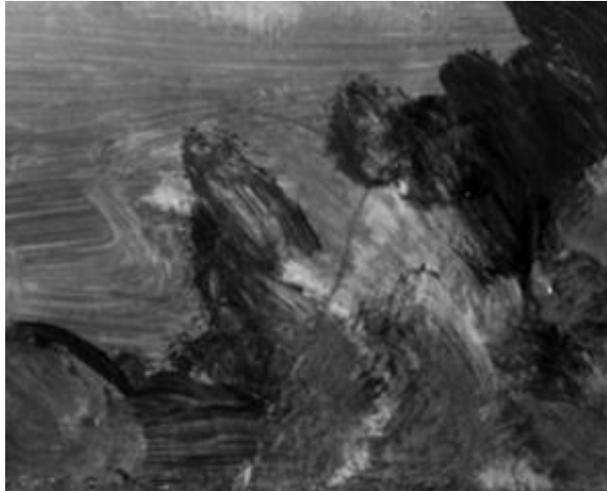
Detail in normal light.

Detail in infrared reflectography.

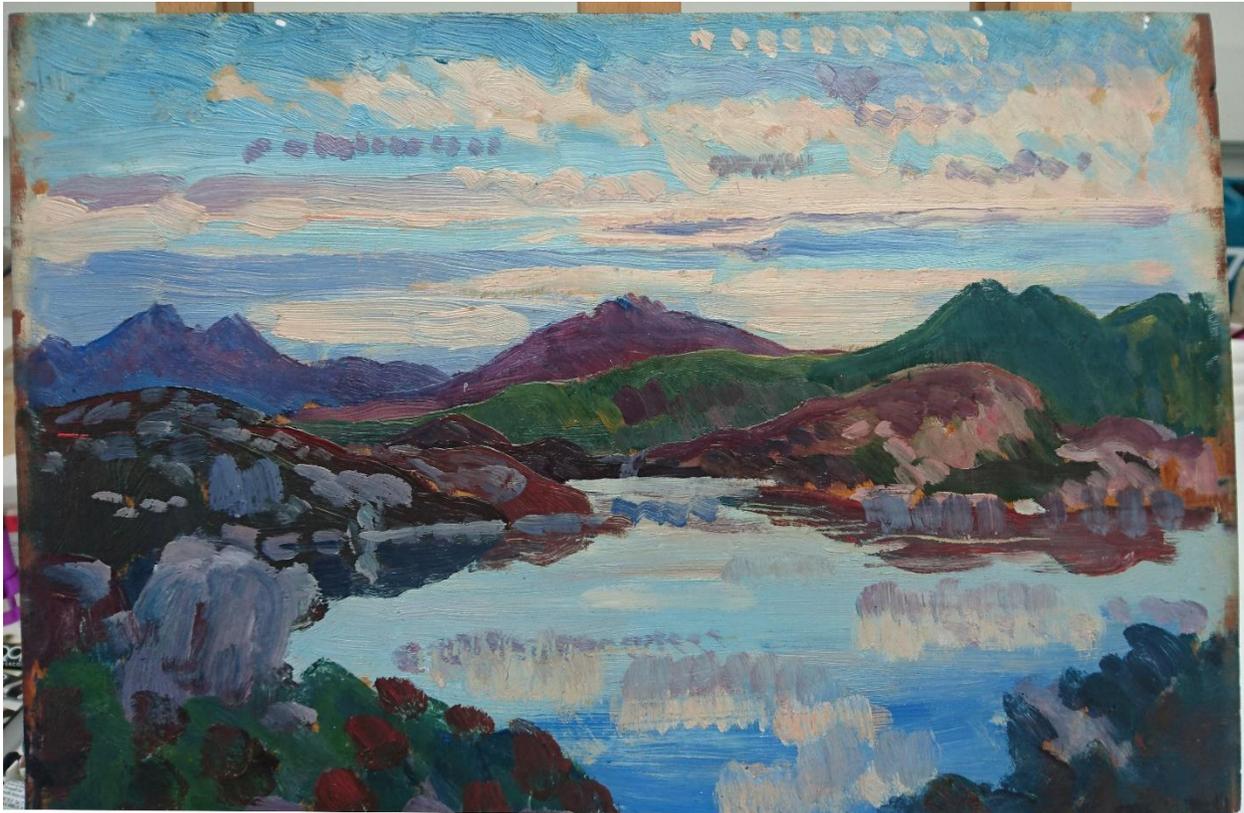
During treatment, cleaning and fills completed.

An isolating varnish of mastic resin at 8% dilution in triple distilled turpentine was applied by brush. Small holes were observed around the perimeter of the top edge. These damages appear to have been caused by nails used to secure the painting in its frame. The small holes were filled with a reversible acrylic putty, Flugger, and textured as necessary to match the surrounding surface. The small and isolated patches of accretions were reduced mechanically with a scalpel under microscope.

Filled damages were inpainted to match adjacent areas. Other small areas of damaged impasto were also inpainted to complete the surface brushstrokes. Inpainting was completed using water-reversible and stable QoR watercolors bound in QoR watercolor medium (Aquazol).

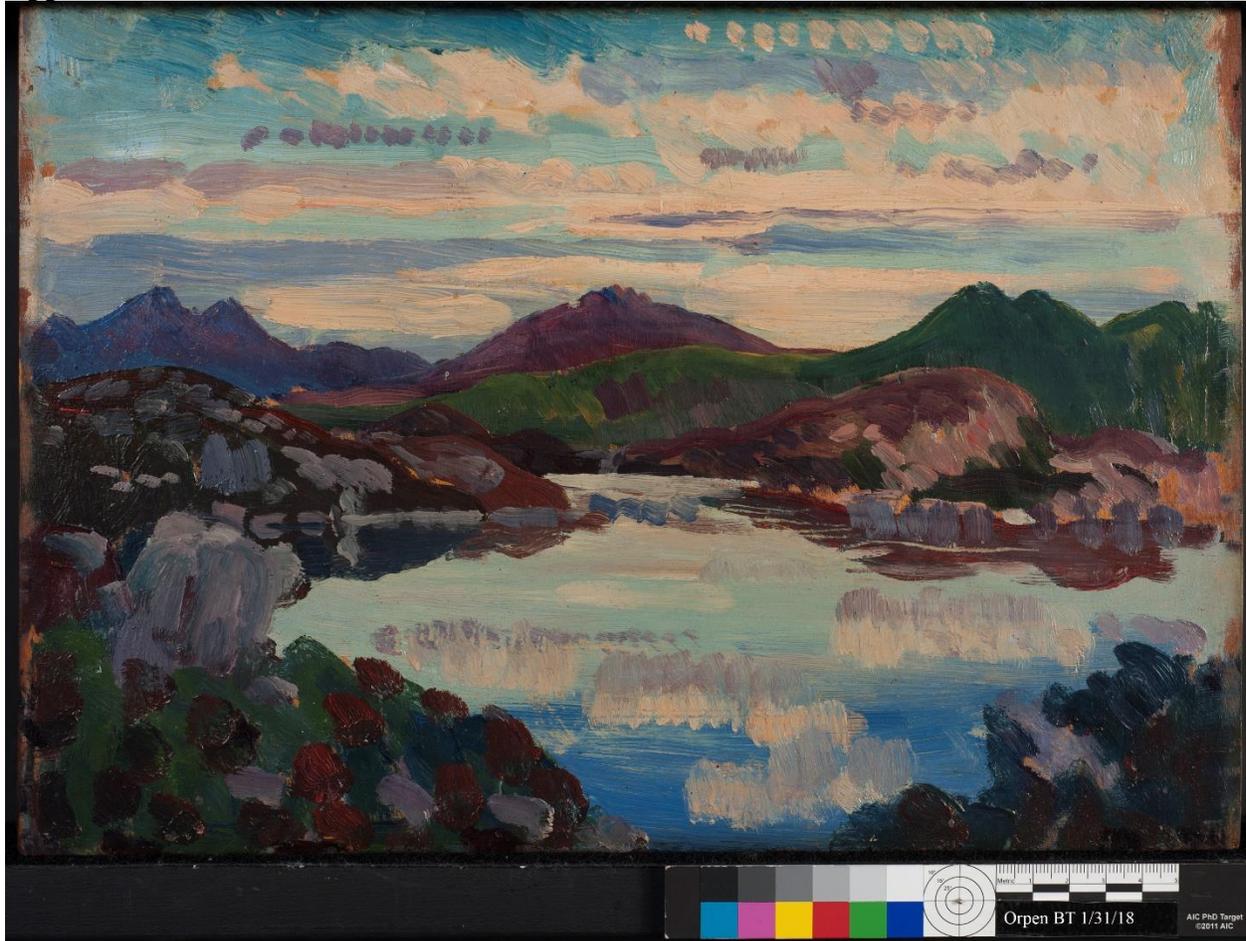
Before treatment, visible light

The paint layer is in good condition with small areas of loss along the top edge. Patchy areas of bare wood are seen along the vertical edges of the board, particularly at the top right. A fine craquelure has developed vertically across the surface in response to the grain of the wood layer below. This cross-grain craquelure is visible in X-ray images.

Small dents in the paint layer are observed around the perimeter of the painting, which could relate to damage from previous framing methods. Small accretions and damage on some areas of high impasto are visible during examination under the microscope.

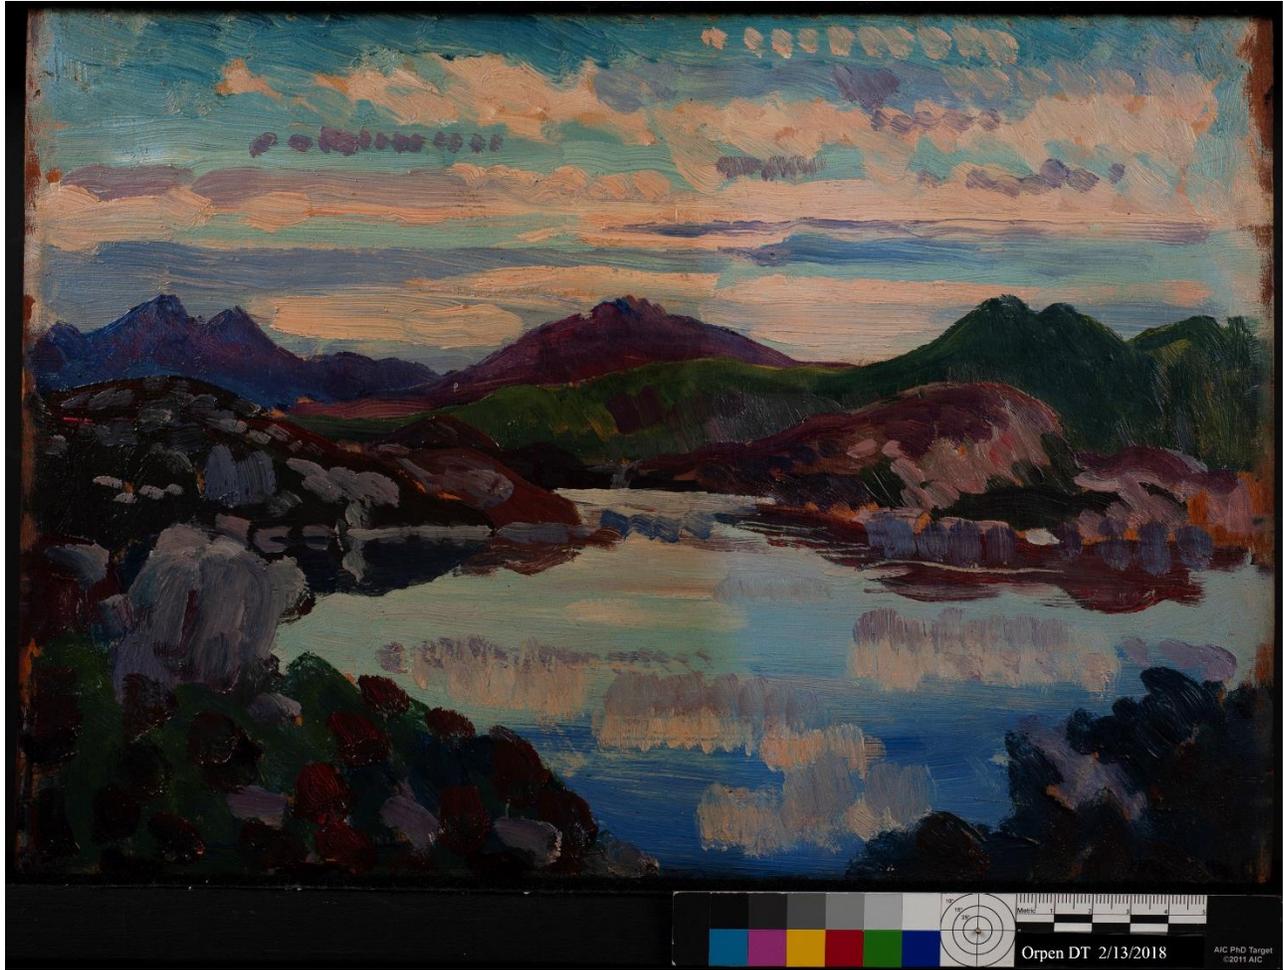
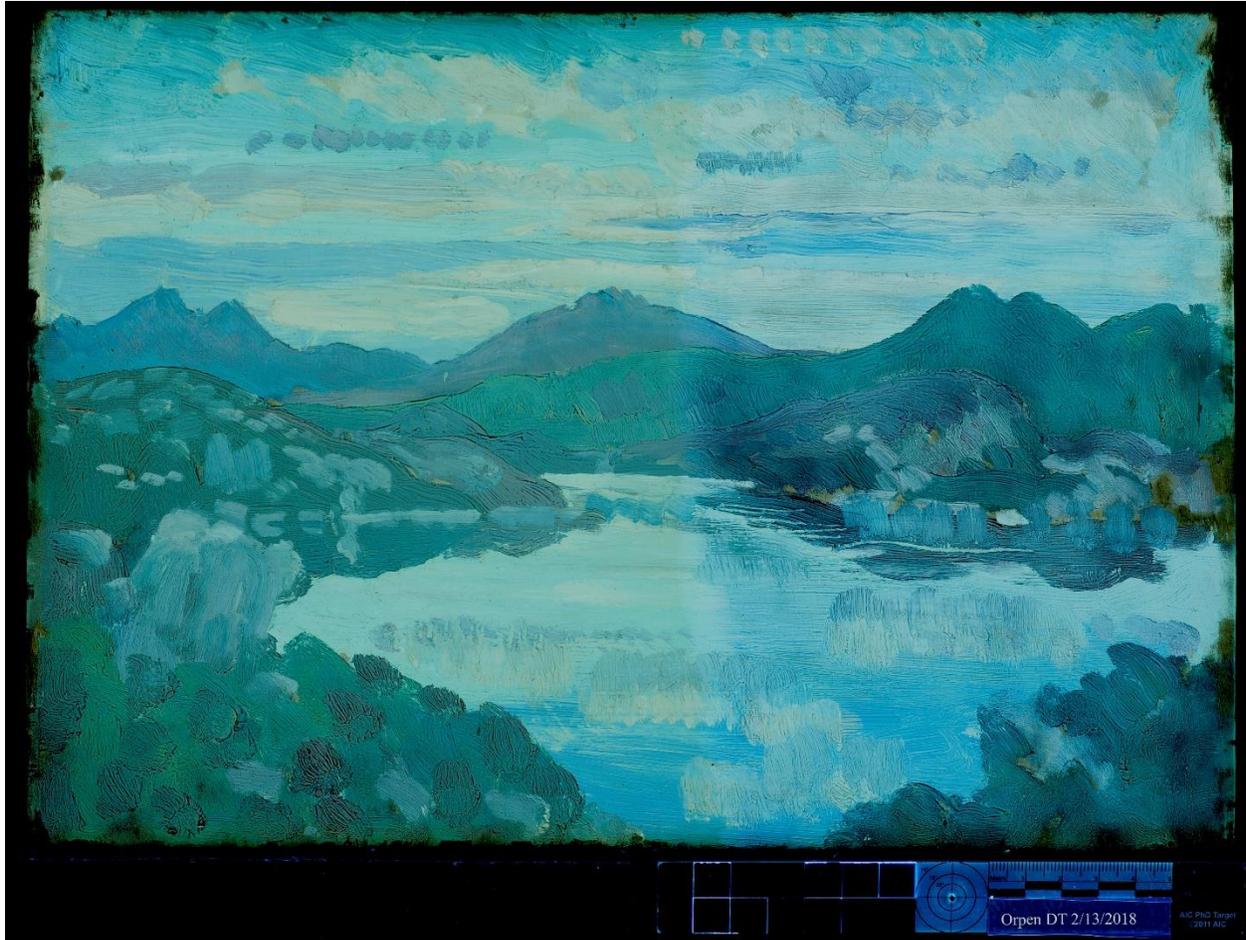
During treatment, varnish removal, visible light

During treatment, varnish removal, ultraviolet light

The reverse of the panel was gently dry cleaned with sponges and the front painted surface was cleaned with moistened cotton to remove loose dirt and dust. The discolored varnish was then removed with a solvent mixture of 1:1 Mineral Spirits and Acetone. No pigments were observed to be sensitive to the solvent mixture.
