**Foundation Number:** HSF0172

**Artist:** Hedda Sterne

**Title:** Airport

**Date of Treatment:** 09/01/2017

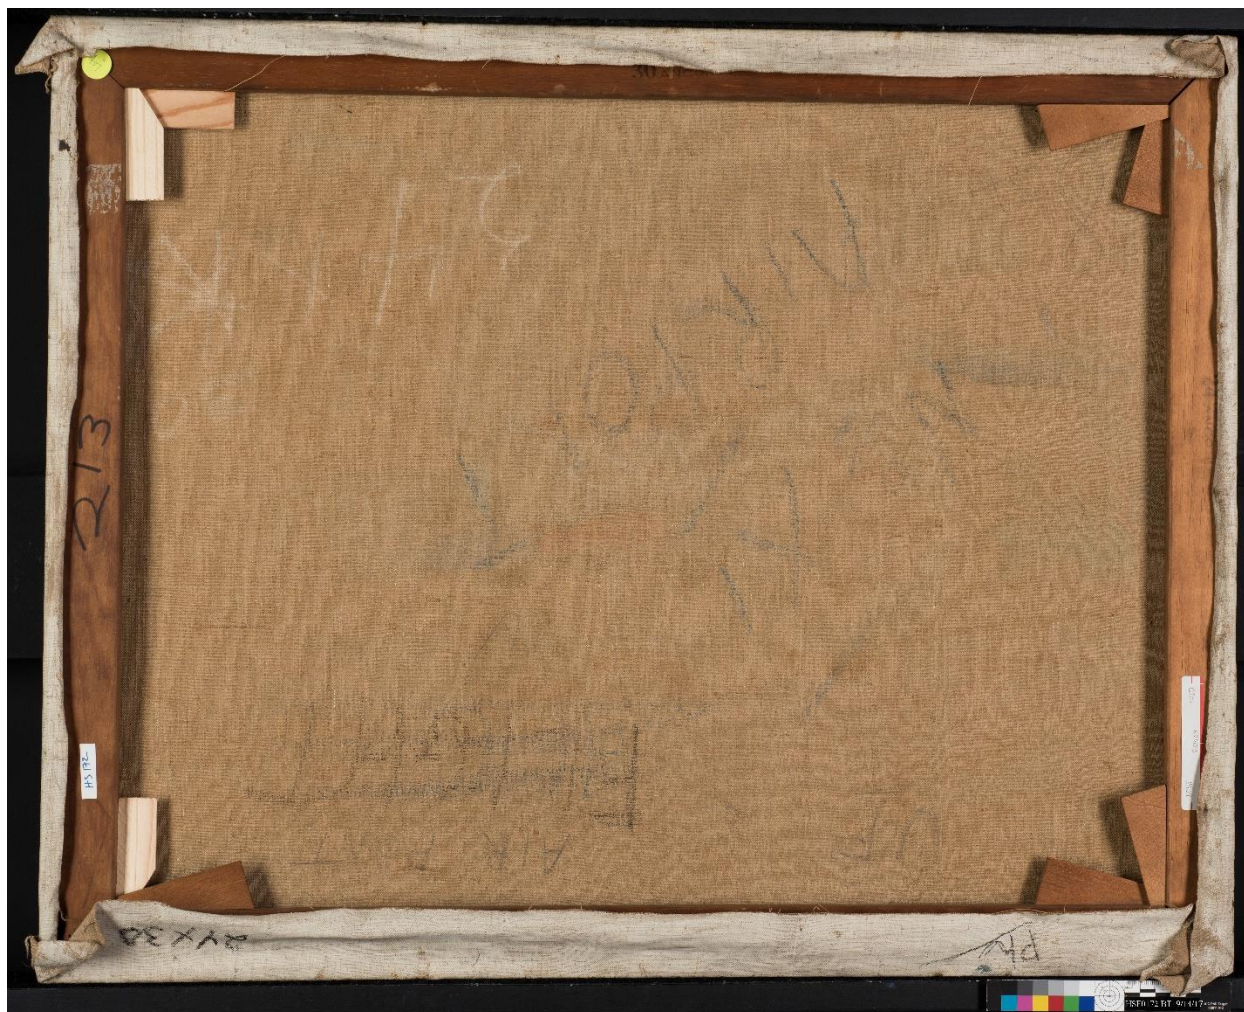
Image 3: Before Treatment, Reverse in normal light.

The stretcher is in good condition with no warping, though is under-built and does not provide adequate support for a canvas of this size. Its joints are slightly expanded on the proper right side (2mm.) while those on the proper left are unexpanded. The canvas is securely attached to the stretcher and its nails are well seated in the stretcher bars.

The canvas retains good flexibility and strength, and is slightly darkened to a light brown color. The canvas is slack with pronounced undulations across the total surface area. Overtime, movement of the loose canvas has caused repeated contact with the inner edge of the stretcher bars, resulting in raised stretcher bar marks and associated mechanical cracking in the paint layers. This is most notable when viewing the canvas in raking light.
