Morland – The Water Mill, 2018

## Treatment Report

**Artist:** George Morland  
**Title:** The Water Mill  
**School/Period:** British, c. 1780-1790.  
**Support/Medium:** oil on canvas  
**Dimensions:** 33.5cm. H x 44.7 cm. W x 1.5 cm D  
**Owner:** Old Westbury Gardens  
**Frame:** Gilded frame, original to painting  
**Date of Treatment:** 1/23/2018

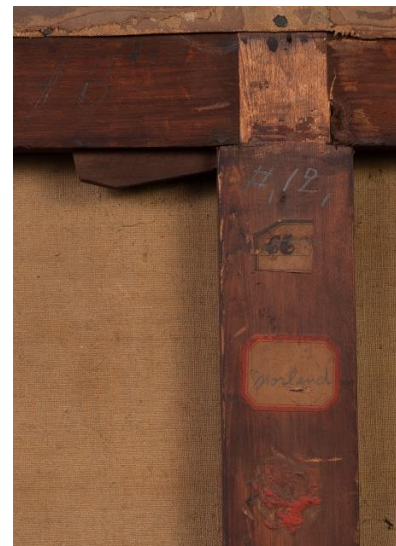
Reverse – Top stretcher bar left of center #[3]; top to middle on the center stretcher bar: #12, small black and white label with 66 crossed out, rectangle white label with red trim with Morland hand-written, red wax seal illegible probably remains of a customs stamp.

Detail of inscriptions and labels on the central stretcher bar.

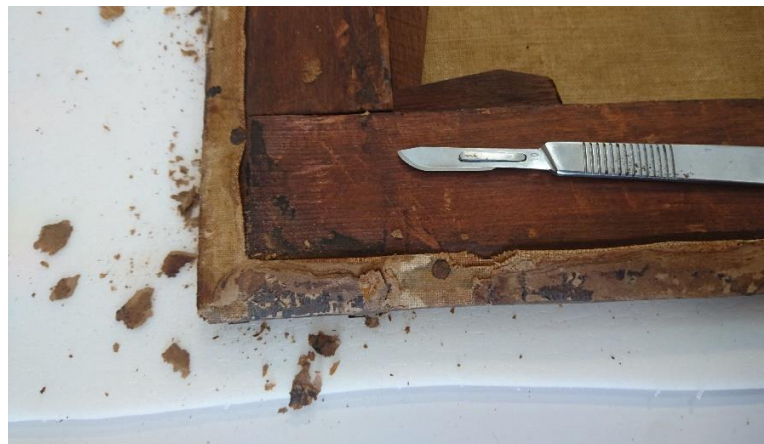
Left side of the canvas is significantly lighter after dry cleaning with sponges. Pine needles can be noted in the removed debris.

The reverse of the canvas and stretcher were dusted to remove loose dust. Several pine needles were found between the bottom stretcher bar and the canvas, causing a slight protrusion. These were removed, and the protrusion relaxed by applying a gentle weight overnight. The canvas reverse and stretcher were then dry cleaned with Absorene rubber sponges to remove accumulated particulates. The brittle remains of the paper tape glued along the tacking edges was removed by scalpel.

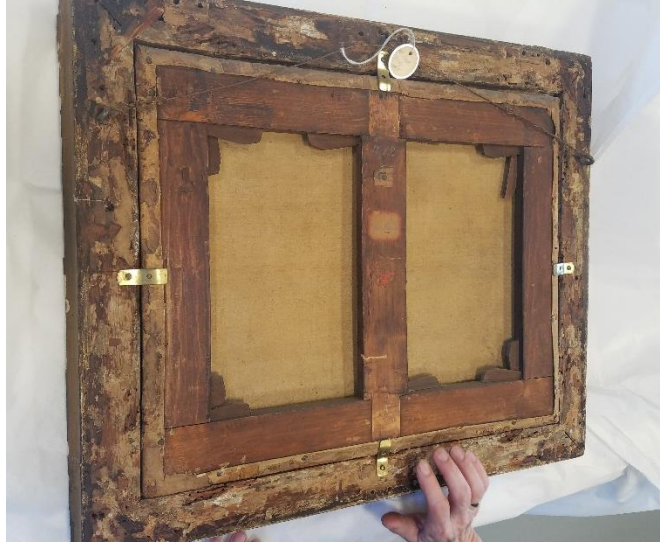
Reverse of framed canvas before treatment.

The stretcher is structurally sound and in good condition. There is a heavy layer of dirt and dust accumulation along the edges of the bottom keys and stretcher bar. The reverse of the lining also carries a layer of dust. The lining is fully adhered to the original canvas and the painting is held at appropriate tension with no undulations in the plane of the canvas. The tacking edges consisting of the lining fabric are in good condition with only two small holes at the center of top and bottom outer edges of the stretcher bar.

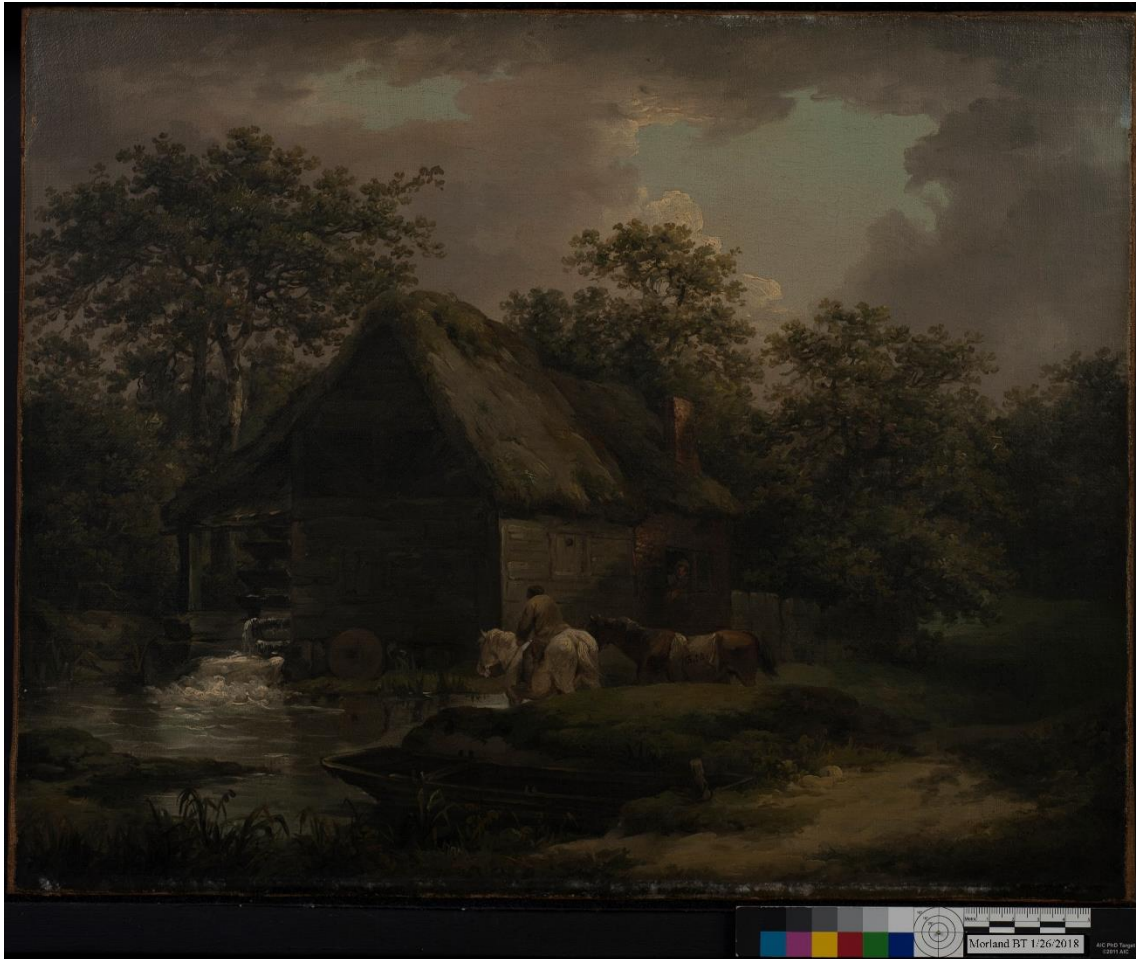
Before treatment, front, visible light.

The natural resin has darkened and yellowed over time, obscuring the subtle details of the painting technique and original palette. The varnish is strongly discolored to a yellow-brown tone, as was revealed by a cleaning test from 3-5 cm below the upper right corner, showing the original. White spots of localized blanching are observed in the top and bottom edges of the painting covered by the rabbet of the wooden frame.

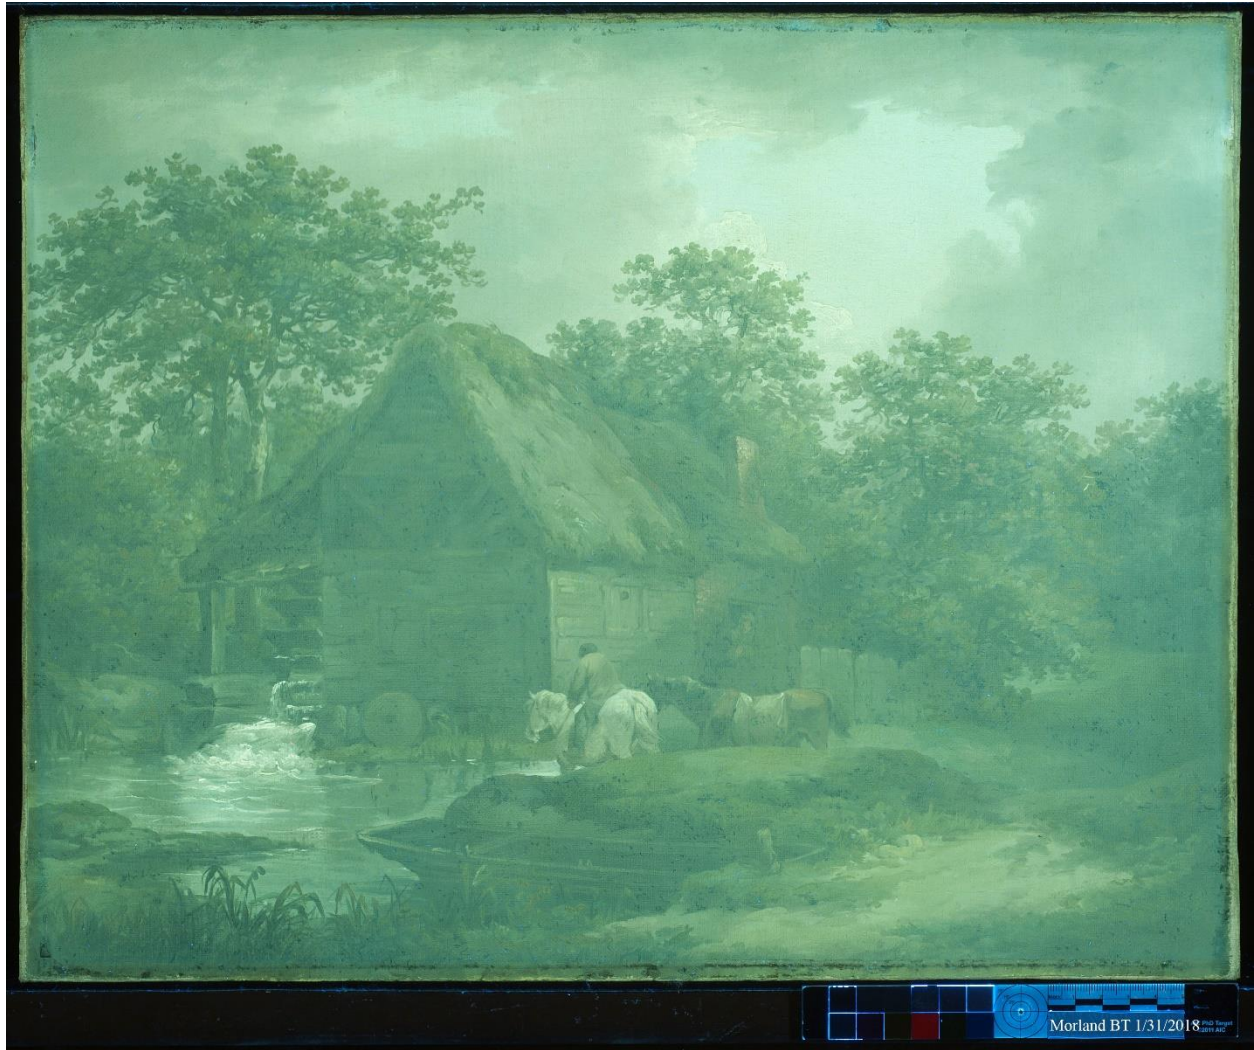
Before treatment, front, ultraviolet light

**Treatment History:** Treatment history is unknown; the painting appears to have previous restorations based on its current state and lining. Examination in ultraviolet light reveals possible areas of retouching.

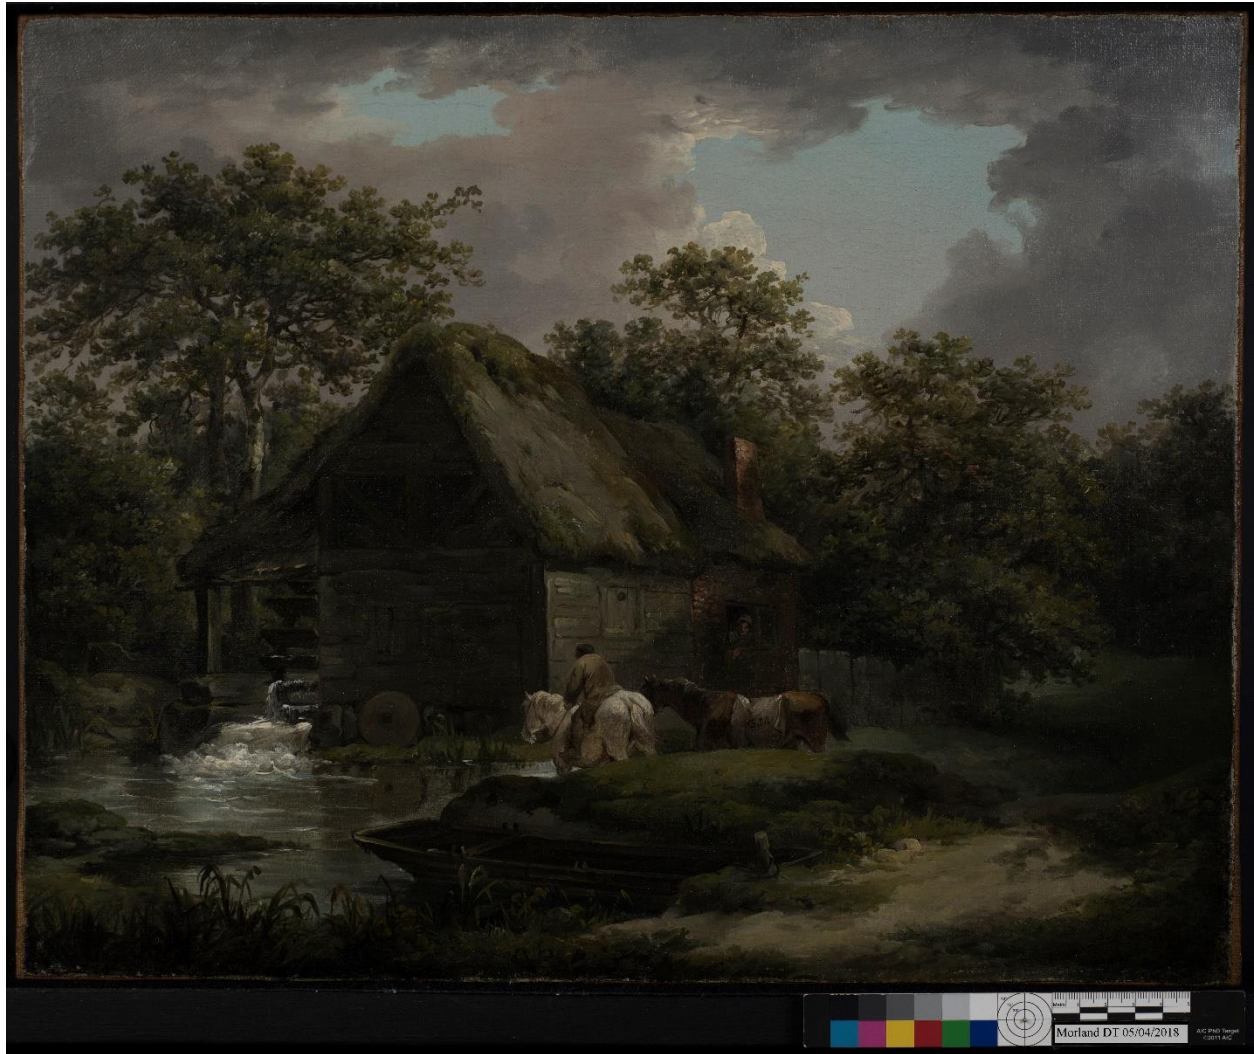
During treatment, cleaned state, front, visible light.

The ground layer is in good condition with no visible losses or damage. After cleaning, it became evident that the white ground was visible through small pinhole losses in the paint layer. During microscopic examination, these white spots protrude from the surface and often have a translucent quality characteristic of lead soap formation. Lead soaps are often formed from ground and paint-layer interactions and the effects of ageing binding mediums. The ground appears radio-opaque and thinly applied in the X-ray image. These observations indicate that the ground layer may contain lead white.

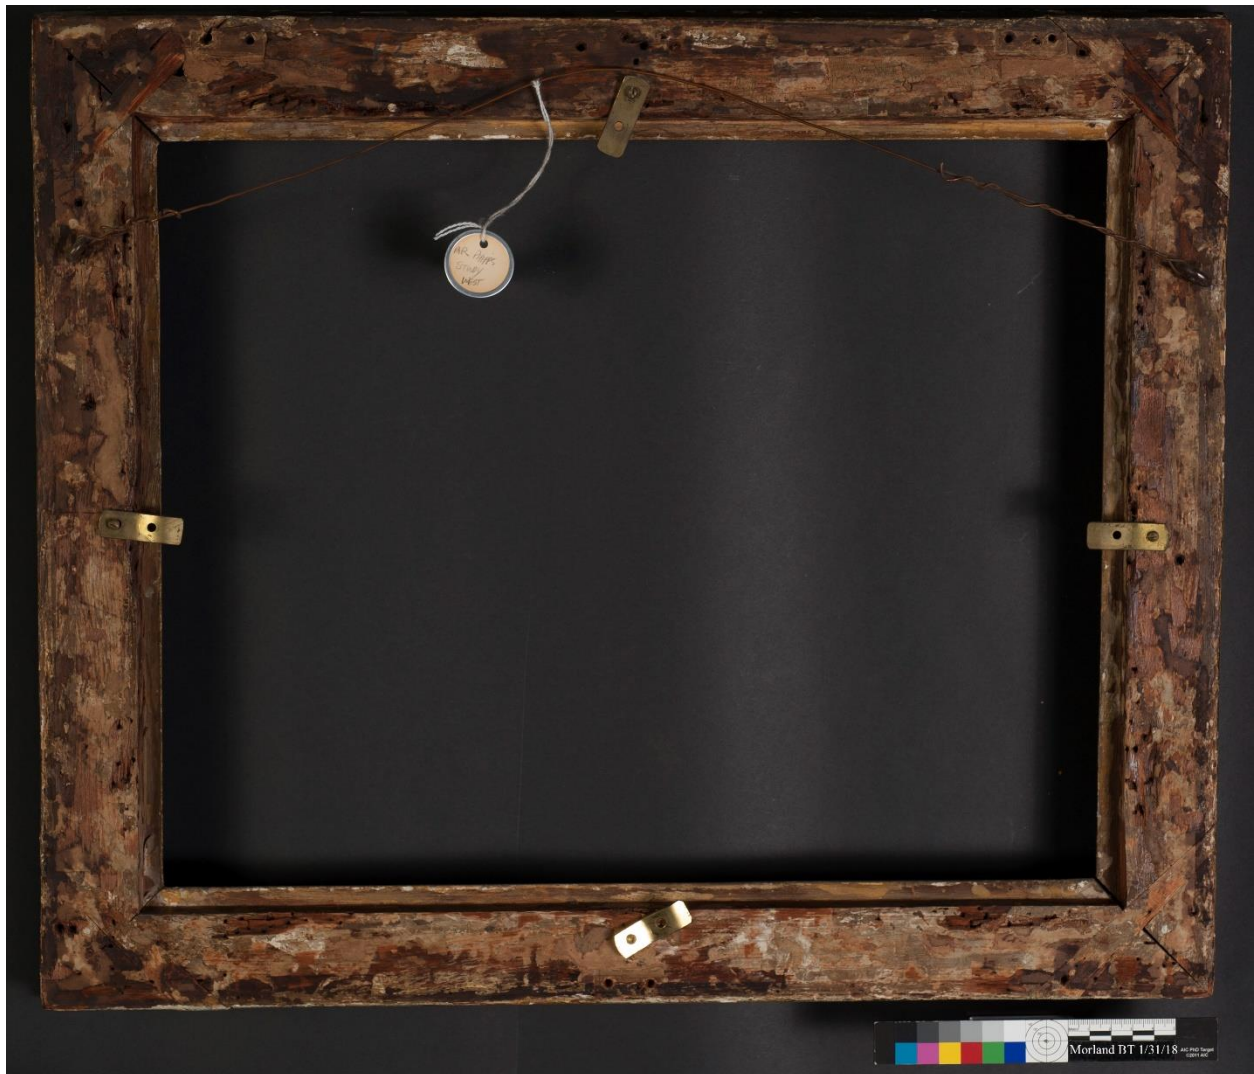
Frame, Reverse

The frame is in very poor condition with large losses and active flaking. Two of the attached leaf decorations are lost along the outer edge of the top left and bottom right corners. Two shield decorations on the interior face are also missing in the top right and lower left corners. Large losses of gesso along the outer edges have left bare wood visible. In some areas, this has been carelessly toned with overpaint, which occurred in several campaigns. Cracks, lifting ground, and loss are also scattered throughout the interior cove of the molding. A heavy layer of dirt, dust, and grime has accumulated over the surface. Due to the extensive damage of the frame it will not be conserved at this time. It is recommended that the frame be replaced by an appropriate reproduction or period frame to suit the painting.
